# 2022 OLD TDF DAM SAFETY INSPECTION REPORT

MYRA FALLS MINE LTD.  
A TRAFIGURA COMPANY  
CAMPBELL RIVER, BC

PROJECT NO.: NX14001B4.3  
DATE: 29 MARCH 2023

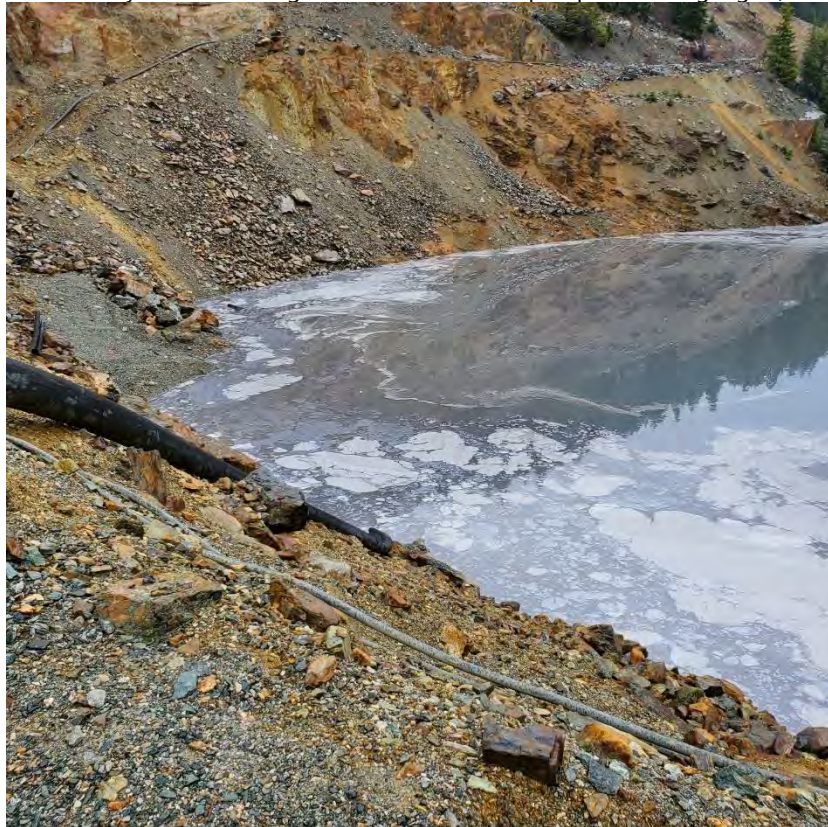
Photo 4: North-west corner of Lynx TDF. (March 22, 2022)

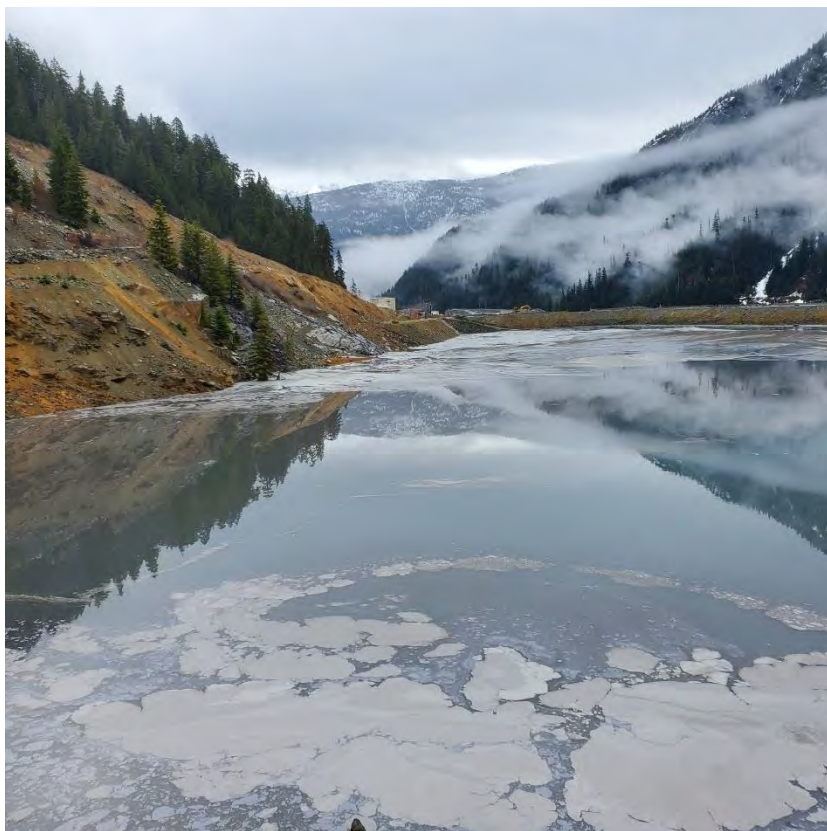
Photo 5: Lynx TDF, looking east with tailings pond covering about 2/3<sup>rd</sup> of the tailings surface. (March 22, 2022)

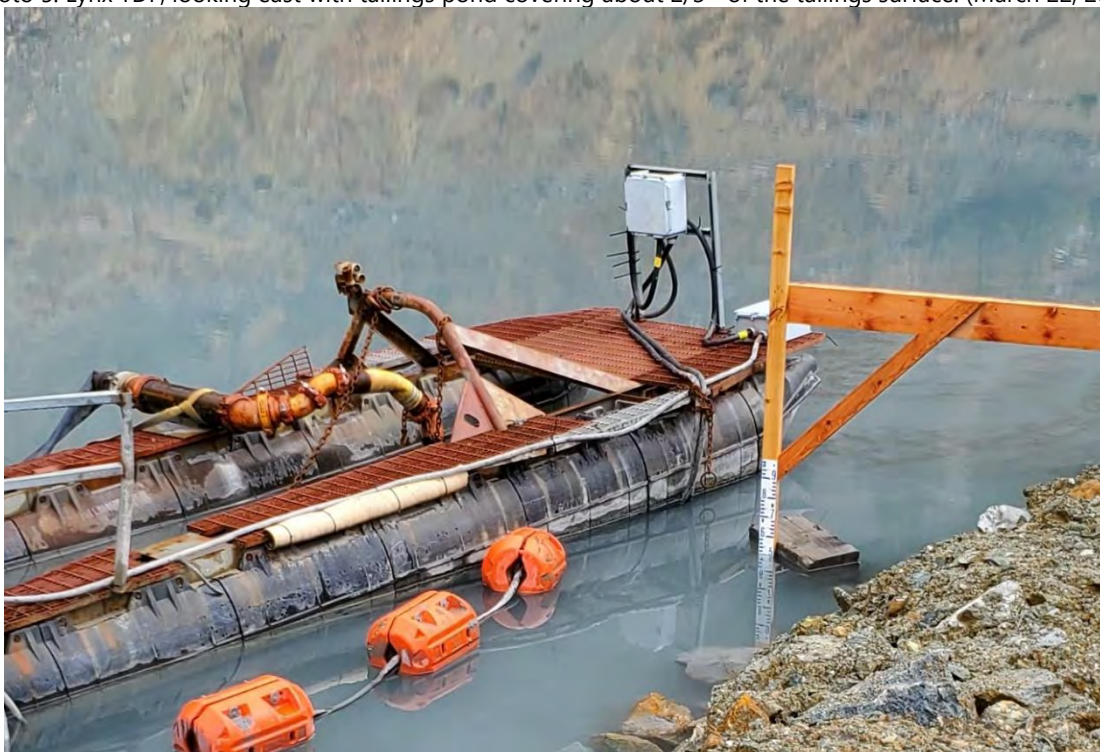
Photo 6: Lynx TDF staff gauge. (March 22, 2022)

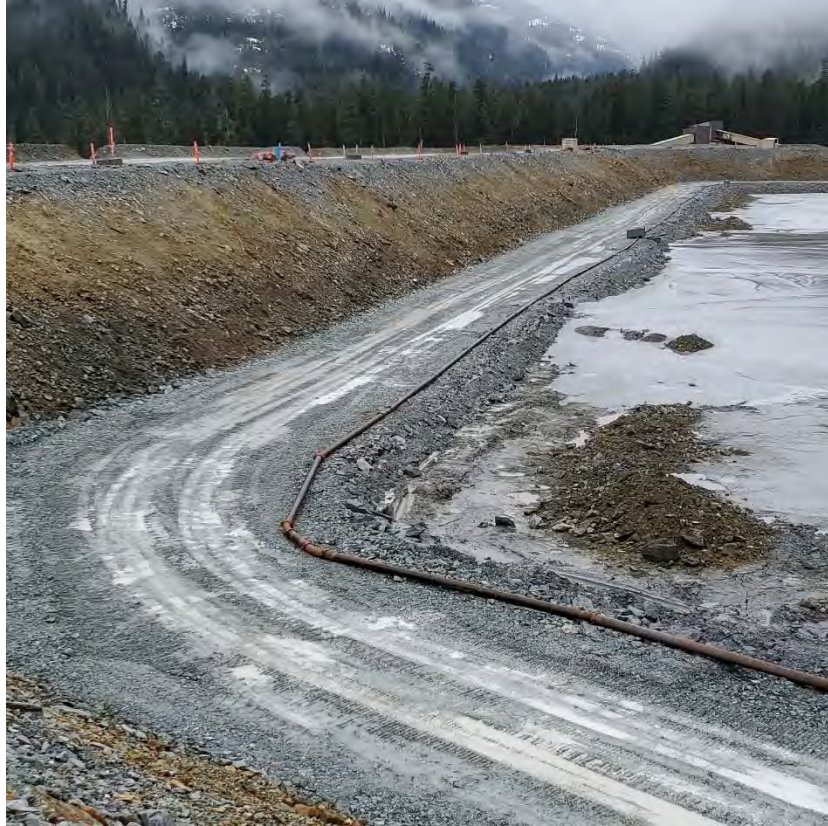
Photo 7: South-east corner of Lynx TDF, looking west. Crest Elevation at 373.5m. Active tailings deposition was observed from a spigot located at the east end of the TDF. (March 22, 2022)

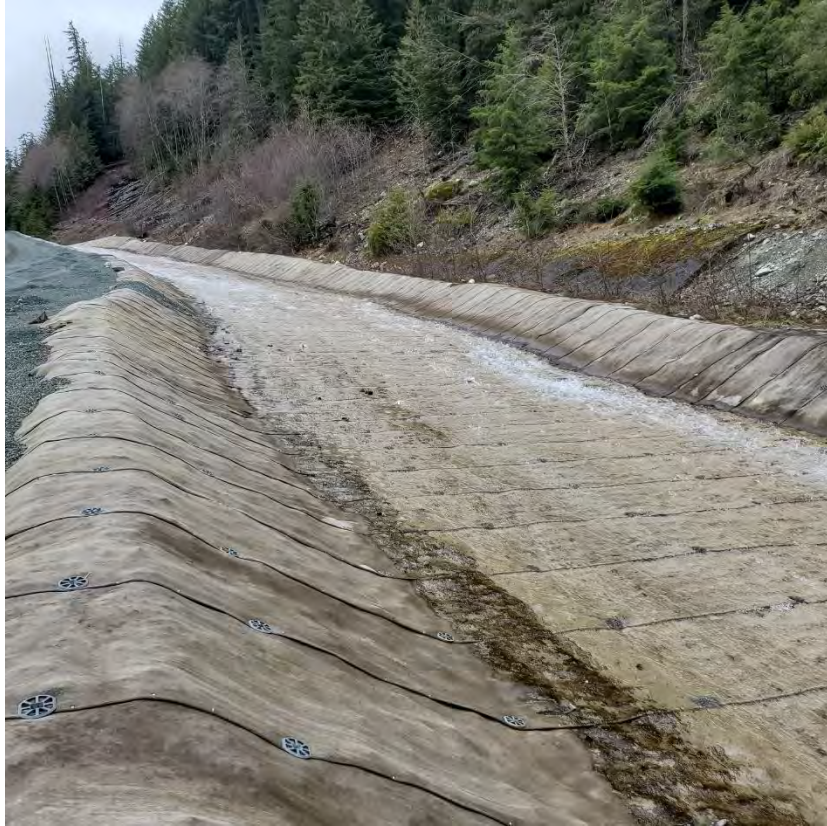
Photo 9: Lower Lynx Diversion Ditch. No unusual performance observed. (March 22, 2022)

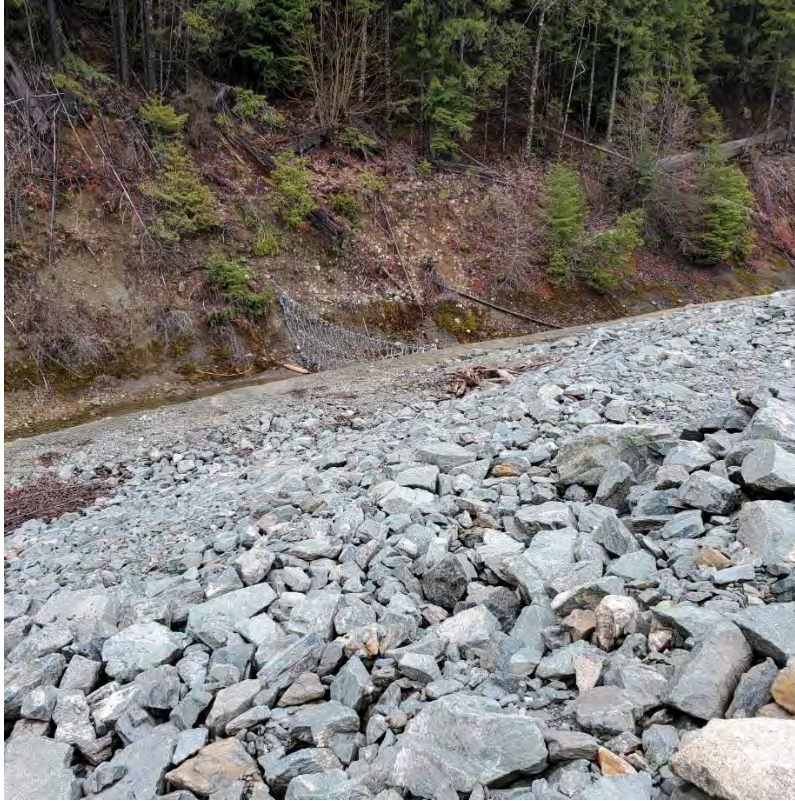
Photo 13: West end of the Lower Lynx Diversion Ditch at the location of the interim debris retaining net. (March 22, 2022)

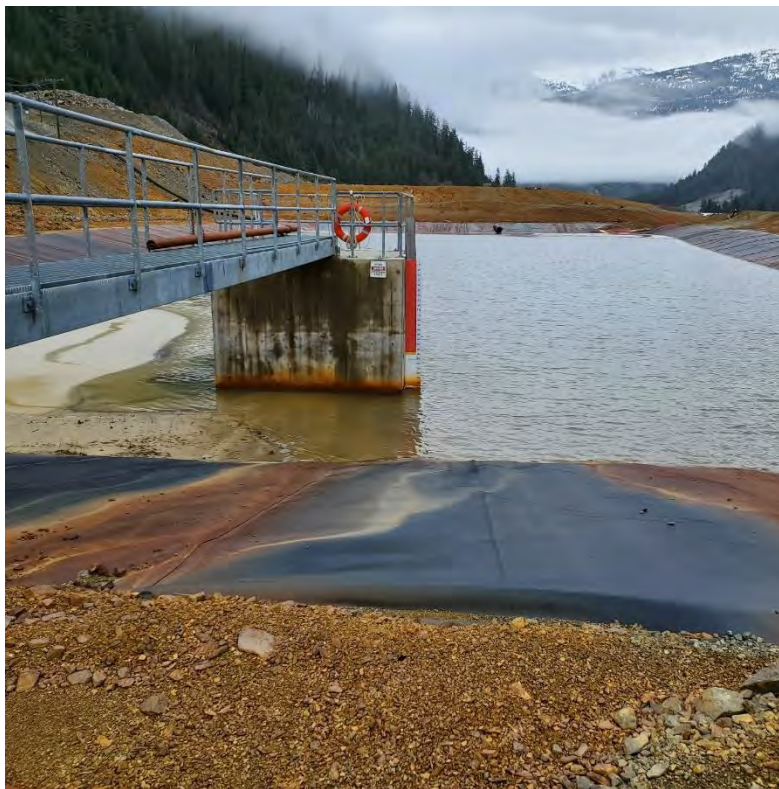
Photo 14: Surge Pond looking east. No unusual performance was observed. (March 23, 2022)

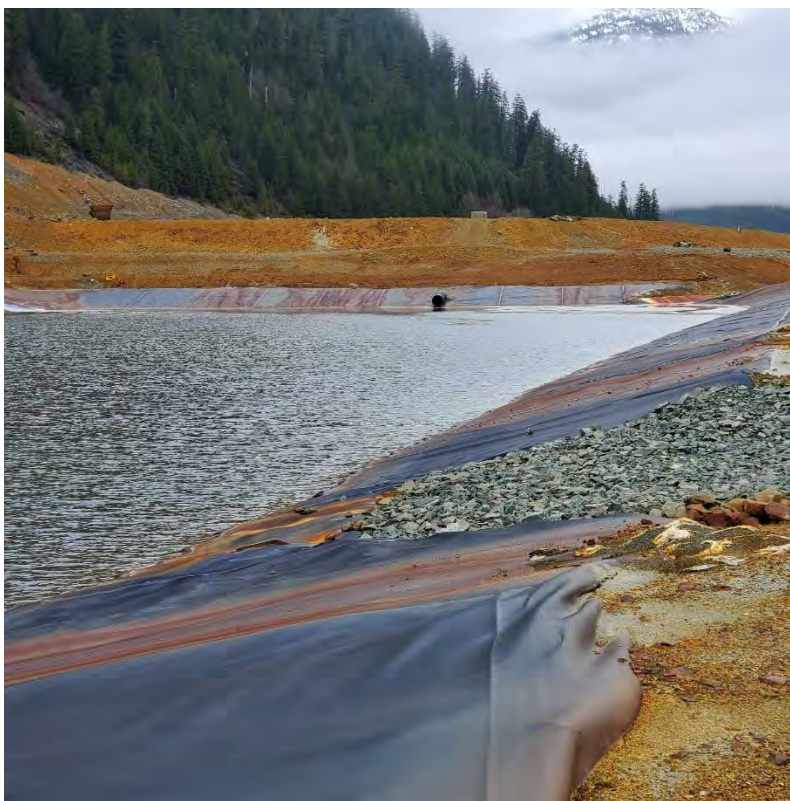
Photo 15: Surge Pond looking north-east. (March 23, 2022)

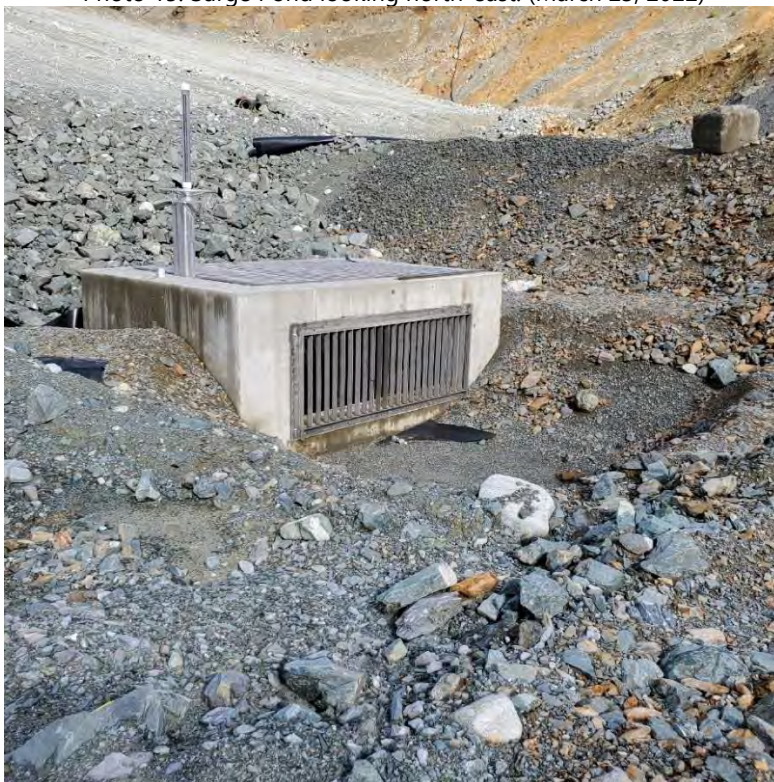
Photo 16: Temporary Lynx Spring Drain Sump. Functioning as intended with discharge observed to be clear. (March 23, 2022)

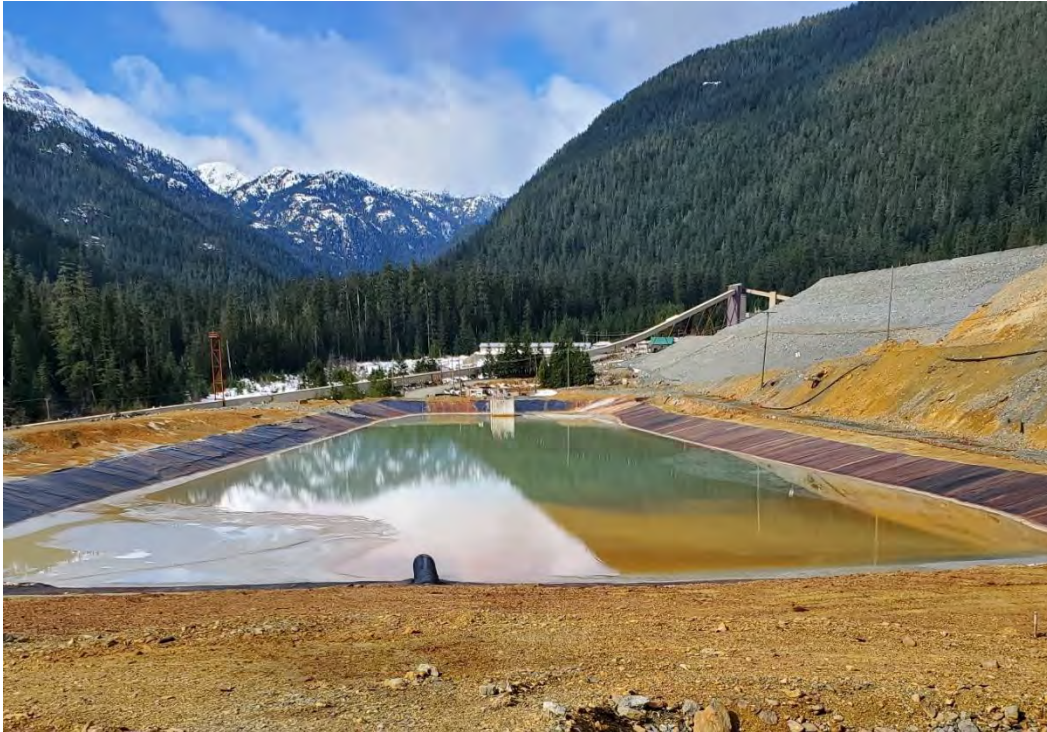
Photo 19: Super Pond at time of site inspection, no unusual performances observed. (March 23, 2022)

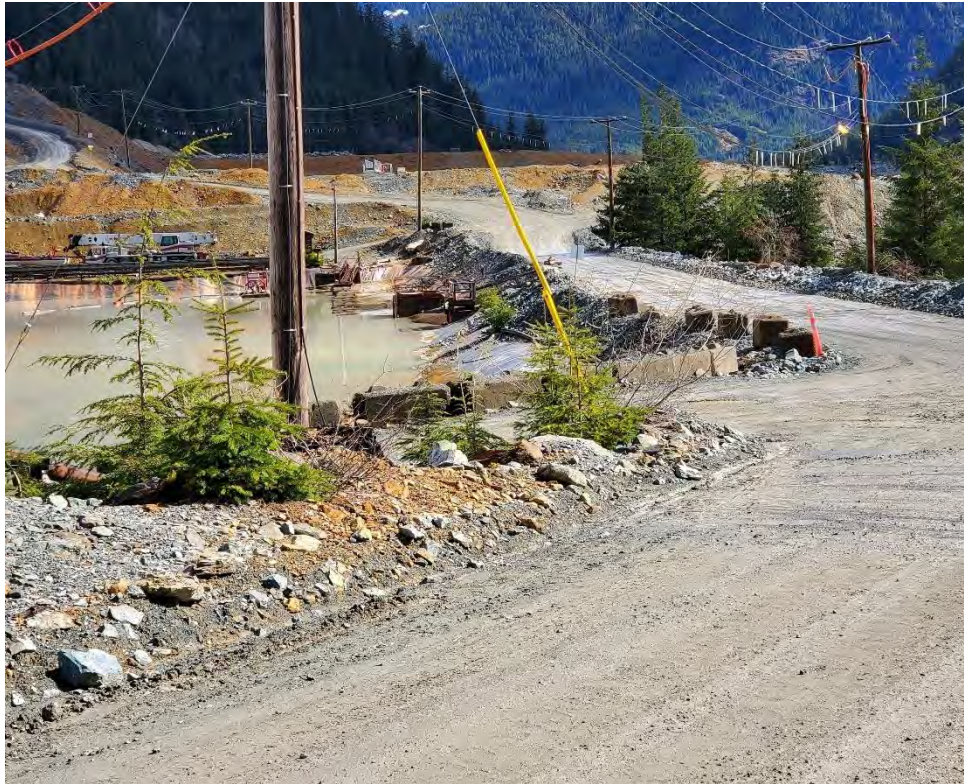
Photo 21: Super Pond Road looking Northeast towards the Old TDF. (March 23, 2022)

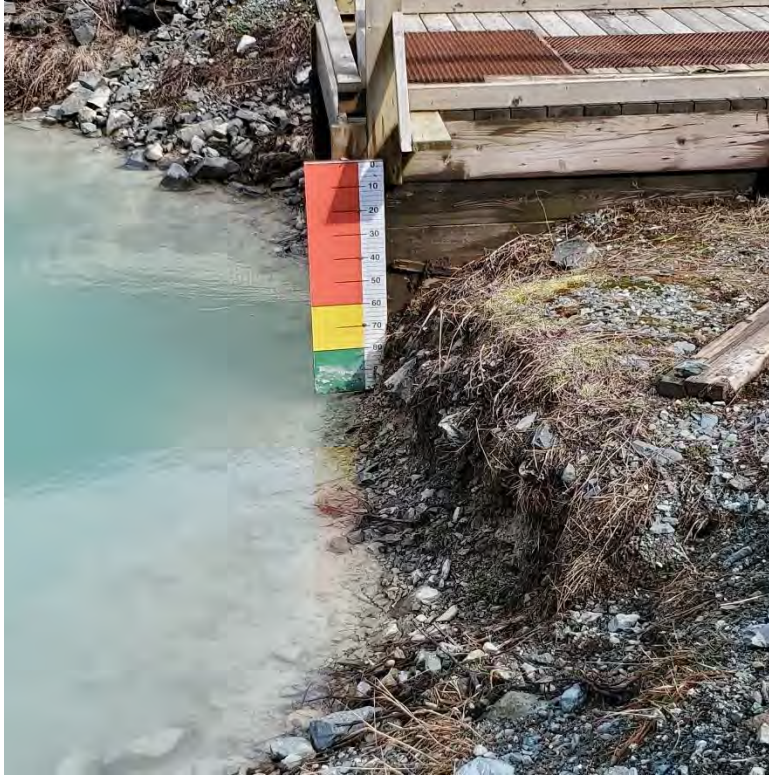
Photo 23: Polishing Pond 3A staff gauge in green zone. (March 23, 2022)

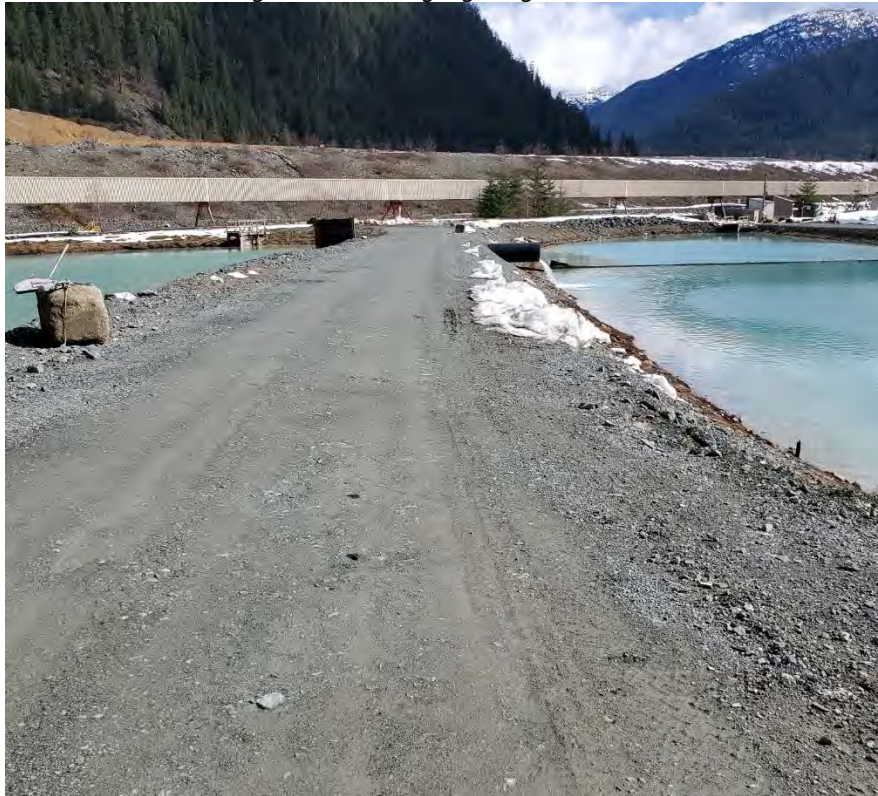
Photo 24: Crest between Polishing Pond 3A and Polishing Pond 4. No unusual performance observed. (March 23, 2022)

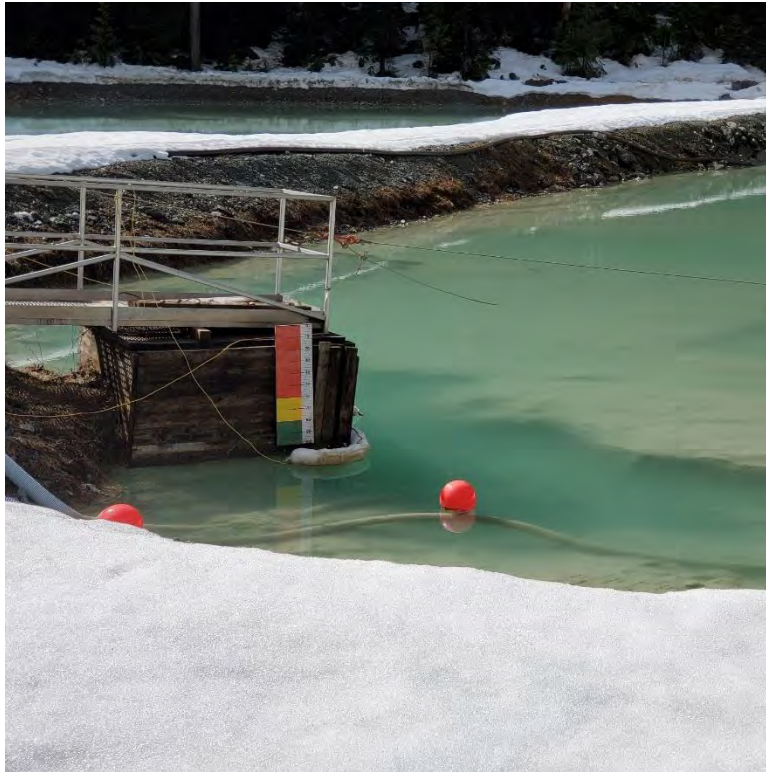
Photo 25: Polishing Pond 2A staff gauge in green zone. (March 23, 2022)

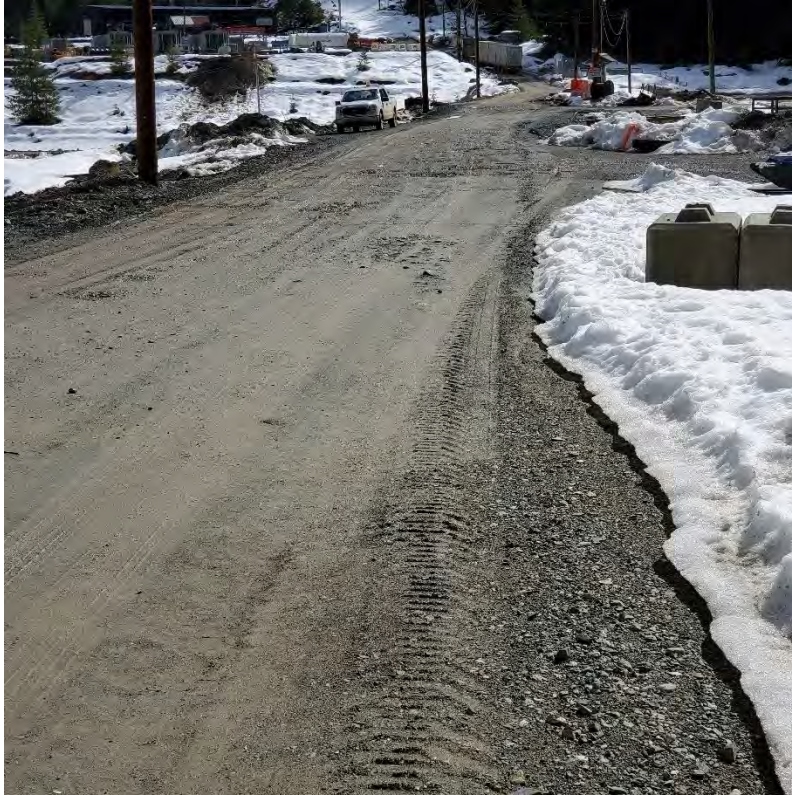
Photo 27: Road between Polishing Pond 4 and Polishing Pond 2 looking East. (March 23, 2022)

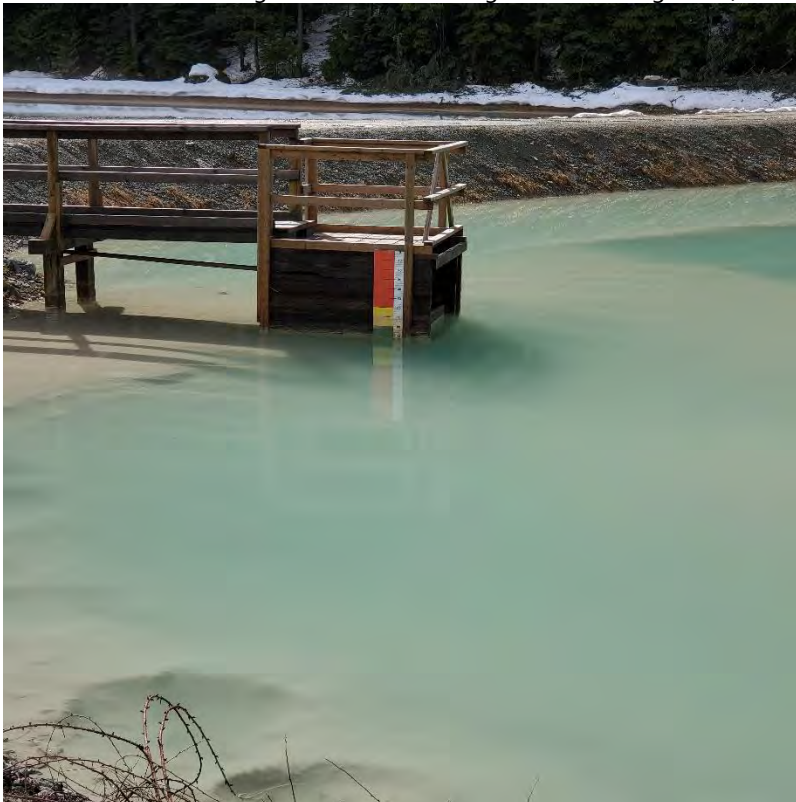
Photo 28: Staff gauge of Polishing Pond 2 in green zone. (March 23, 2022)

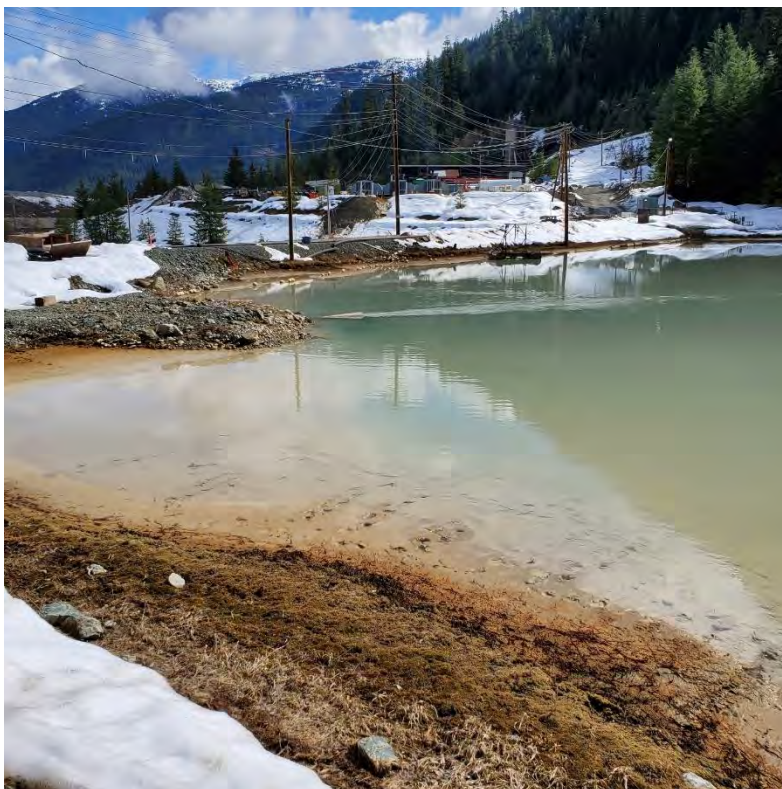
Photo 29: Polishing Pond 1 looking East. (March 23, 2022)

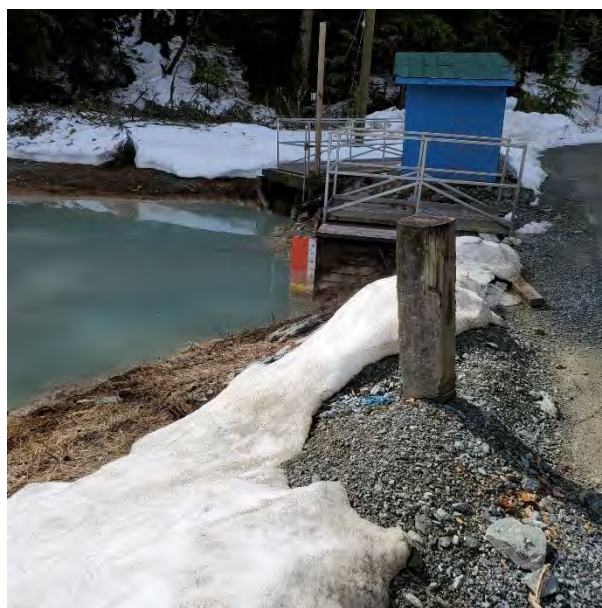
Photo 30: Staff gauge of Polishing Pond 1. (March 23, 2022)

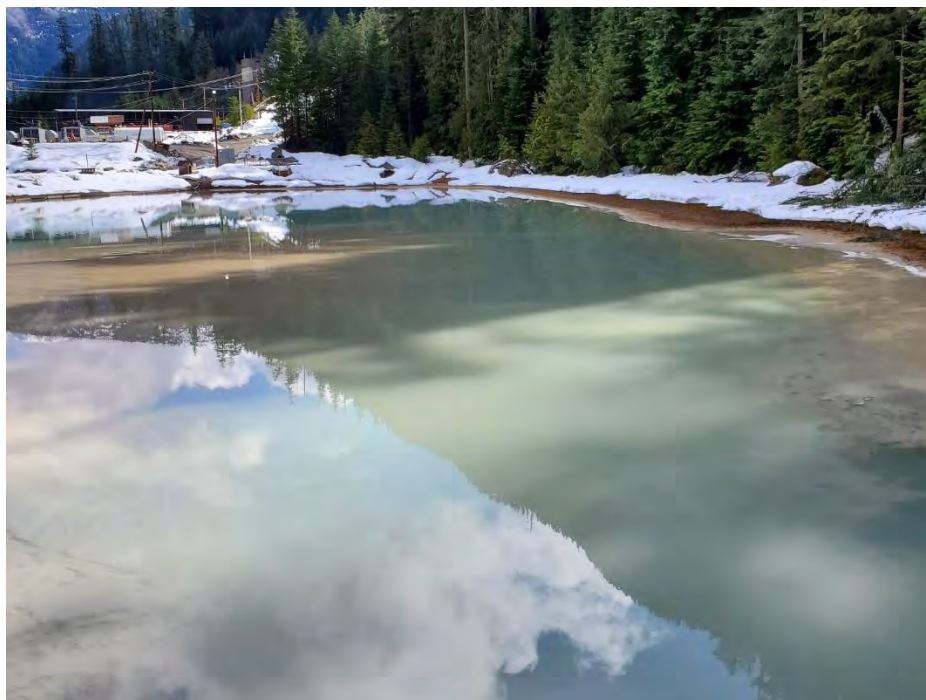
Photo 31: Polishing Pond 1 looking Southeast. (March 23, 2022)

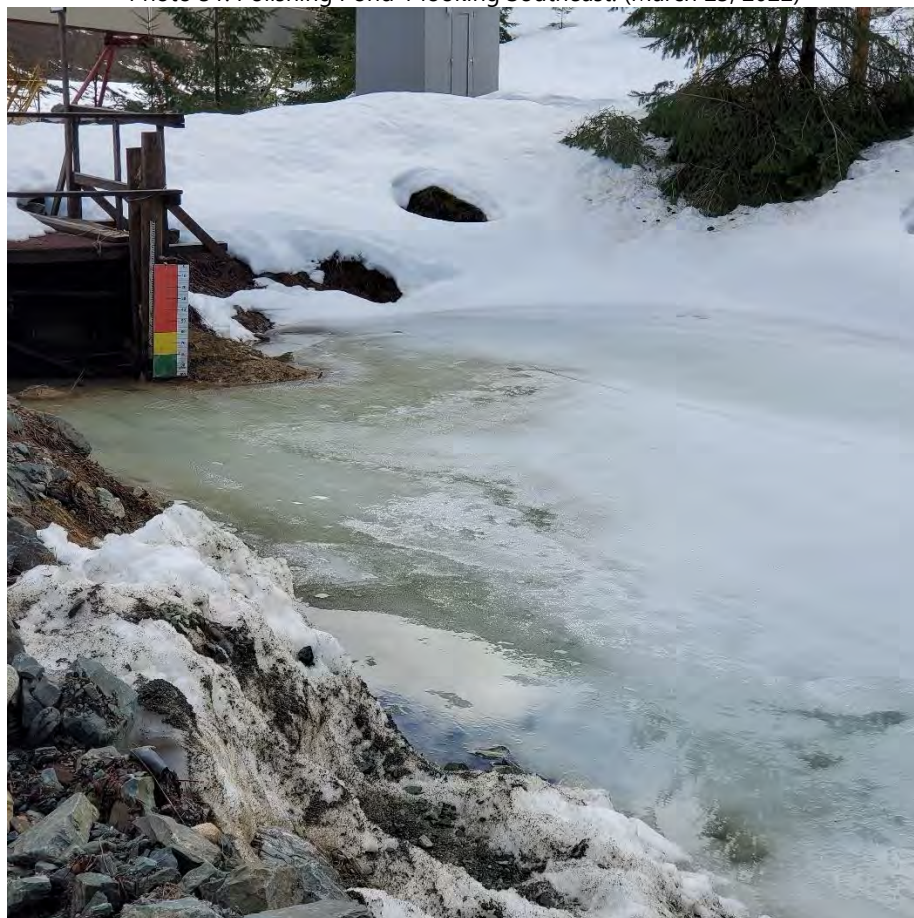
Photo 32: Polishing Pond 3 observed to be empty with staff gauge in green zone. (March 23, 2022)

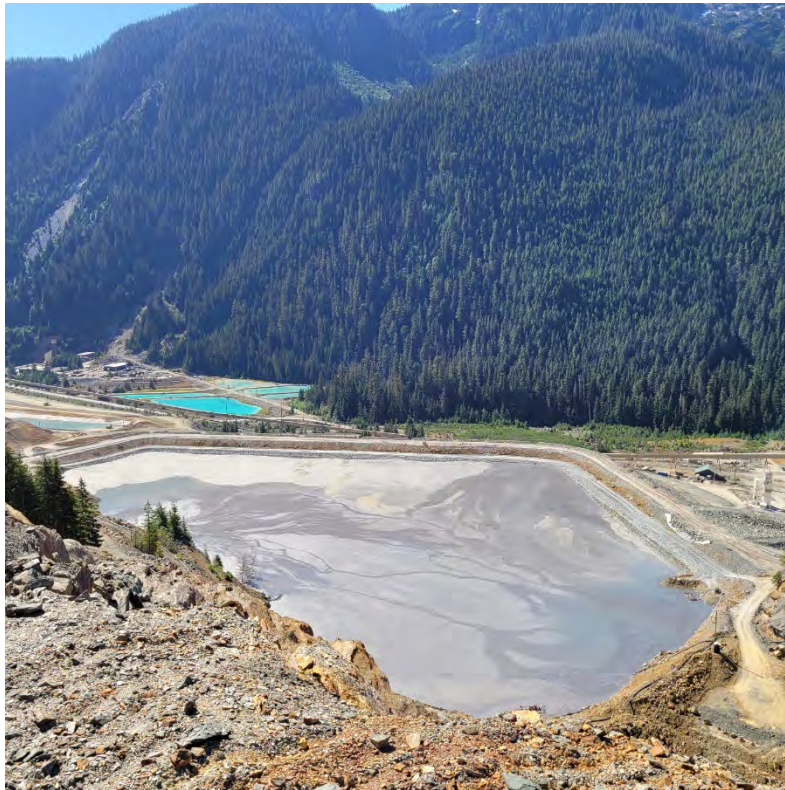
Photo 1: Lynx TDF

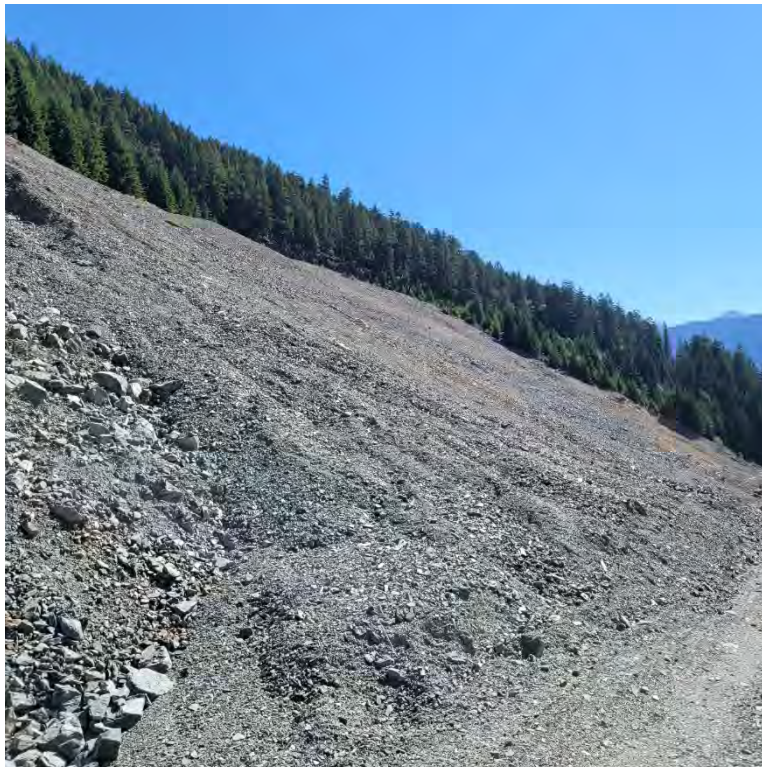
Photo 2: Waste Rock dump area in the northeast corner of the Lynx TDF

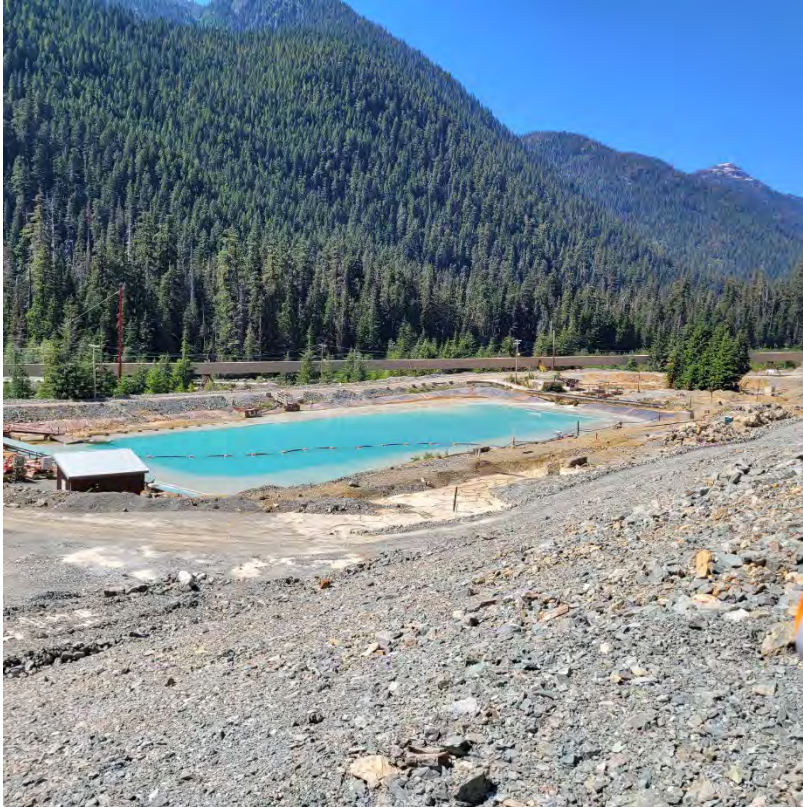
Photo 3: Super Pond at time of site inspection.

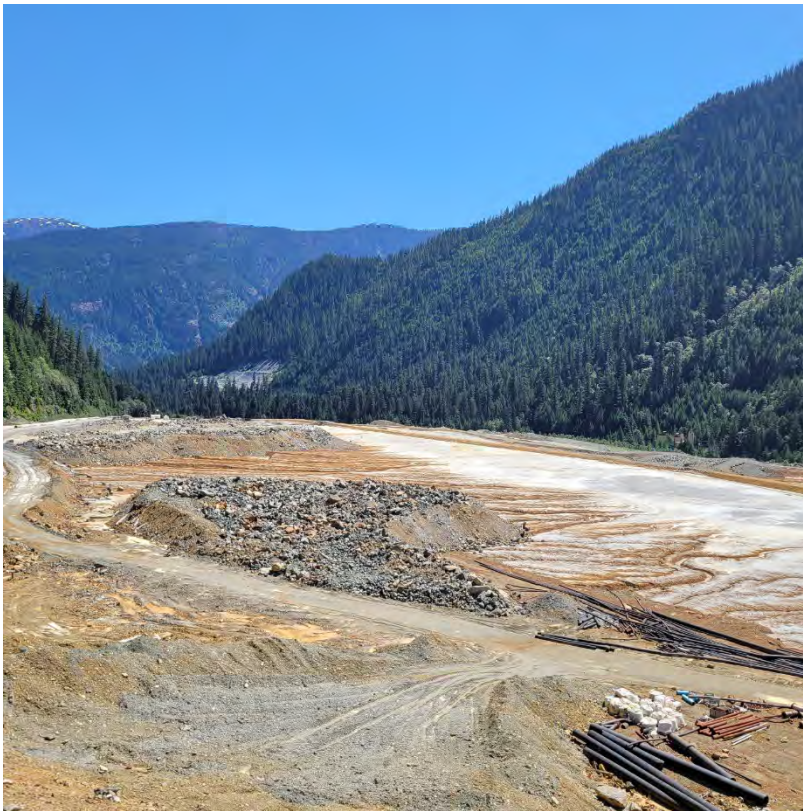
Photo 4: Waste rock stockpile at the back end of Old TDF

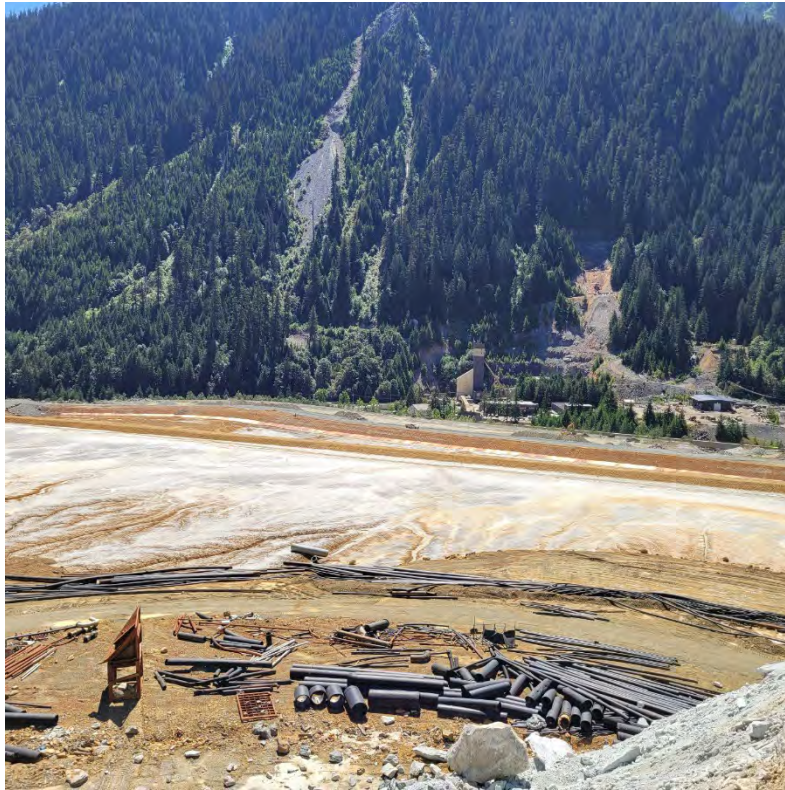
Photo 5: Storage area at the back end of Old TDF

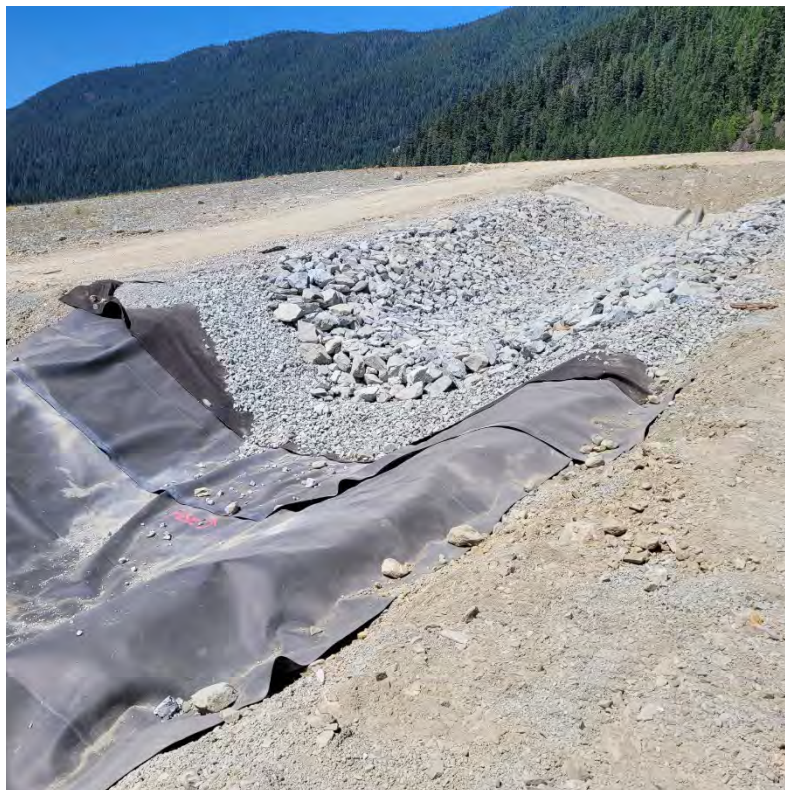
Photo 6: Geomembrane and geotextile liner along the spillway of Old TDF

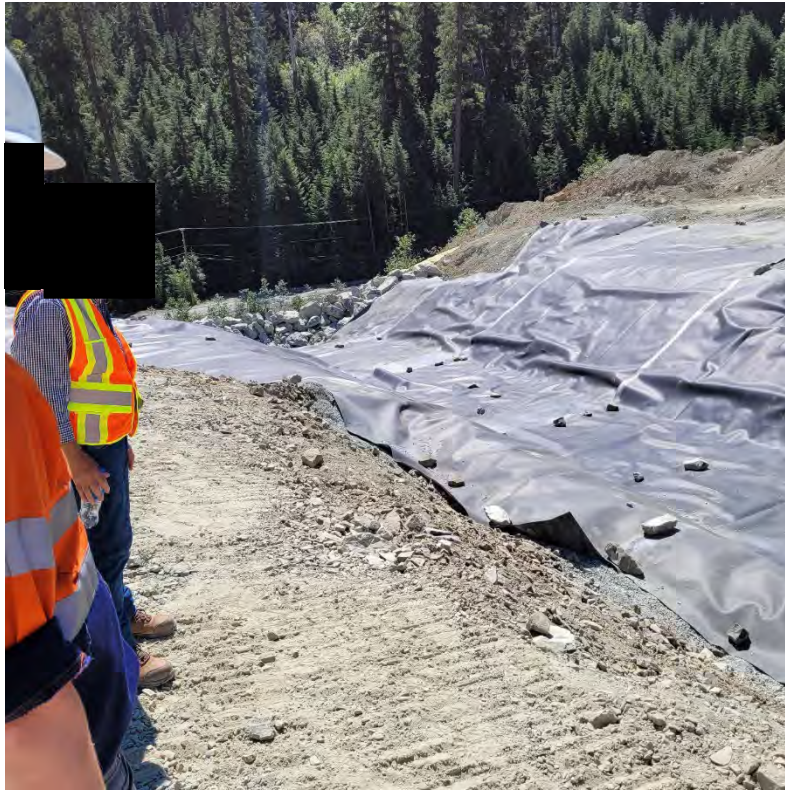
Photo 7: Liner system of the Old TDF spillway

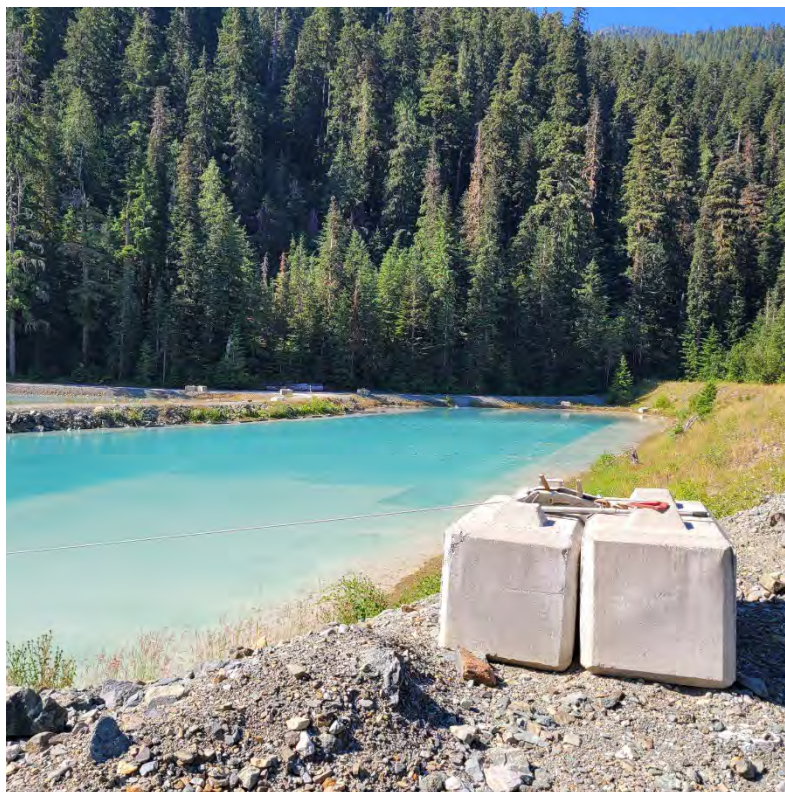
Photo 8: Polishing ponds under normal operating conditions

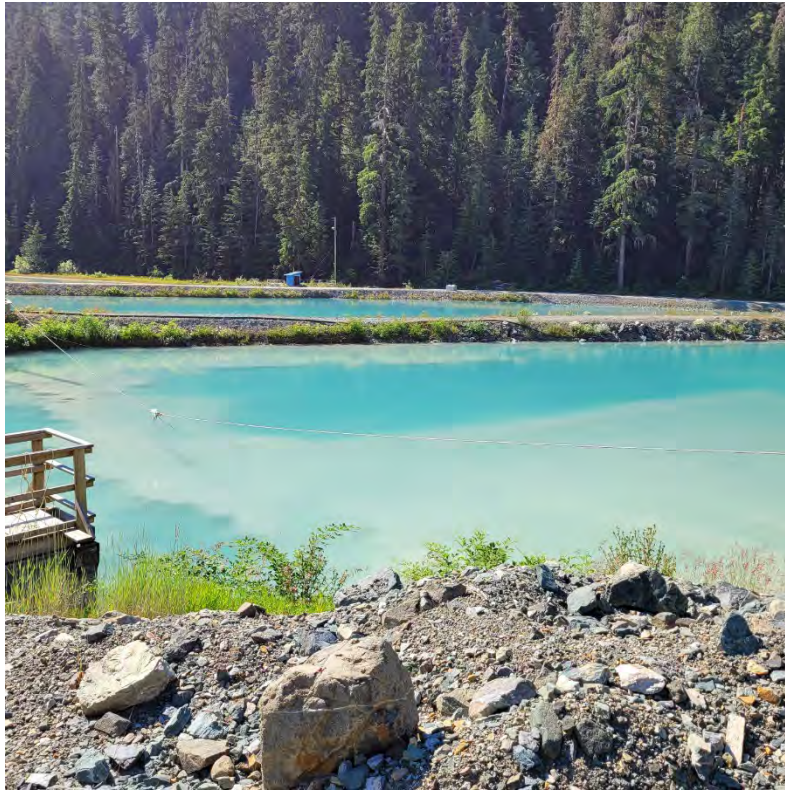
Photo 9: Polishing ponds under normal operating conditions

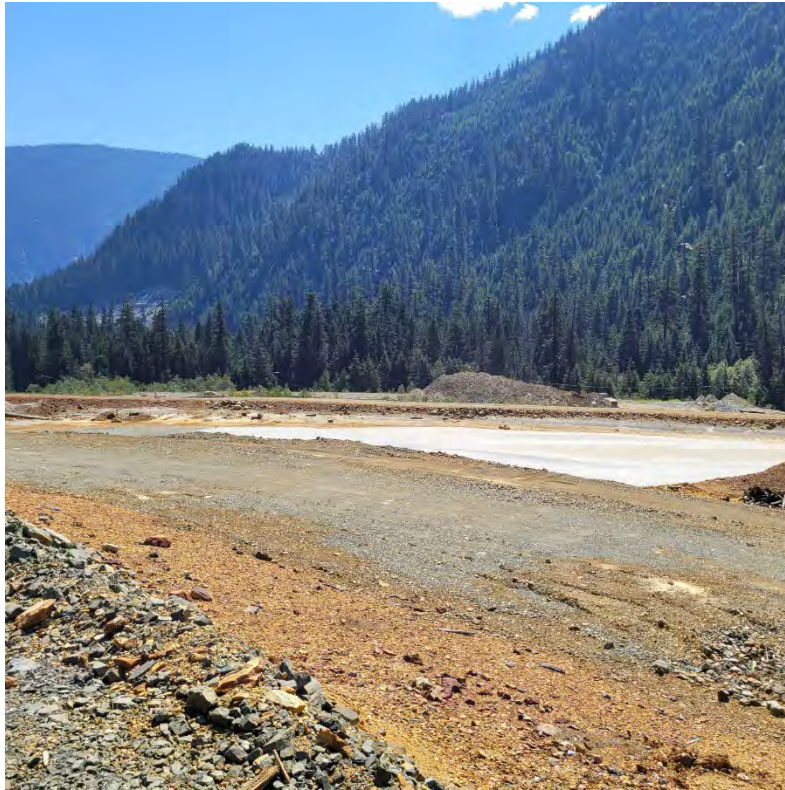
Photo 11: East corner of Old TDF with a small pond and tailings inside the East Strip

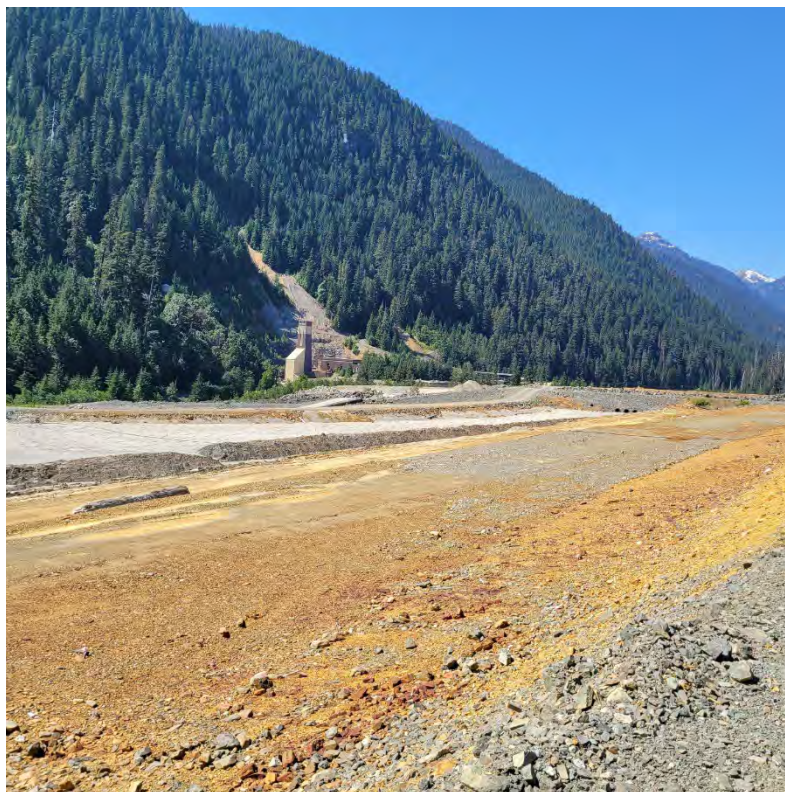
Photo 12: East Strip looking towards the west

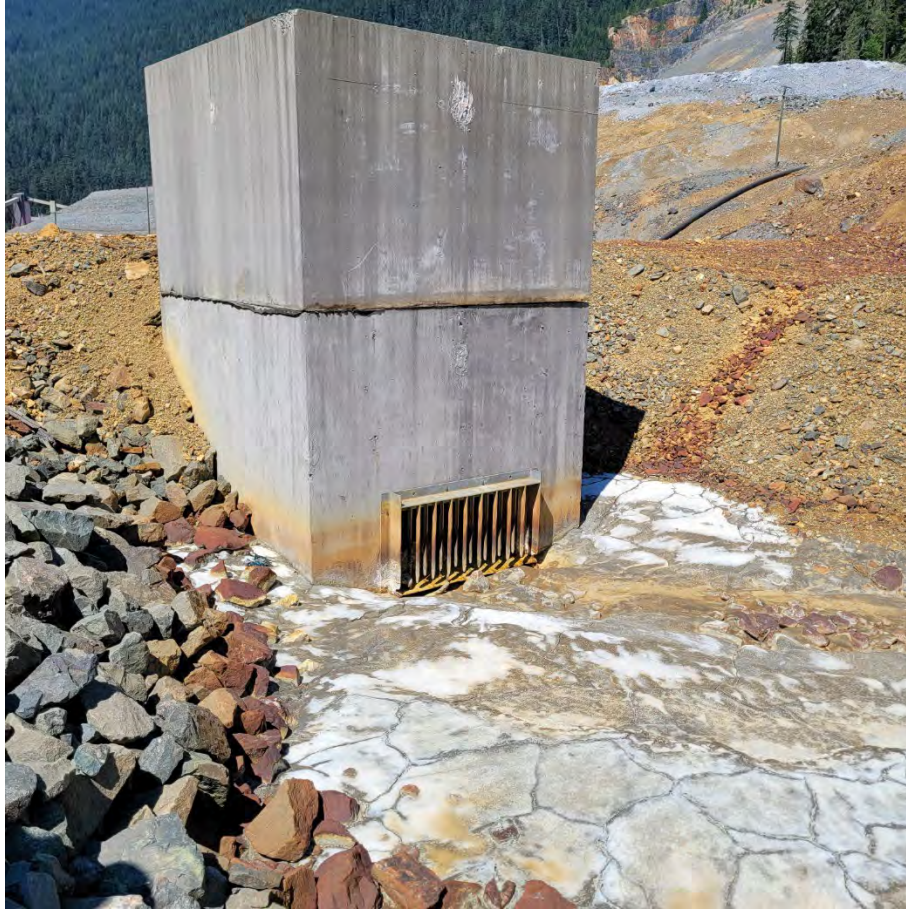
Photo 13: East decant structure with approximately half of the bottom 2 cm's of the vertical grating bars being dissolved.

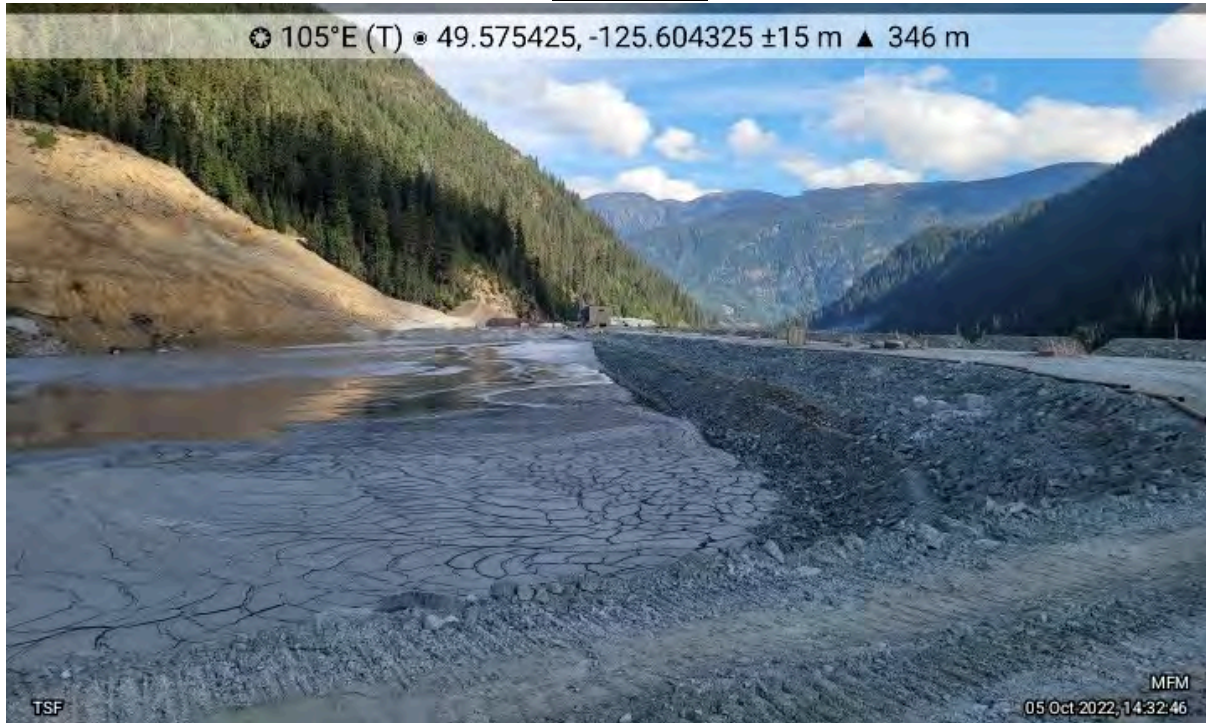
Photo 1: Lynx TDF looking East. Active tailings deposition was observed from a spigot located at the east end of the TDF
