# 2022 OLD TDF DAM SAFETY INSPECTION REPORT

MYRA FALLS MINE LTD.  
A TRAFIGURA COMPANY  
CAMPBELL RIVER, BC

PROJECT NO.: NX14001B4.3  
DATE: 29 MARCH 2023

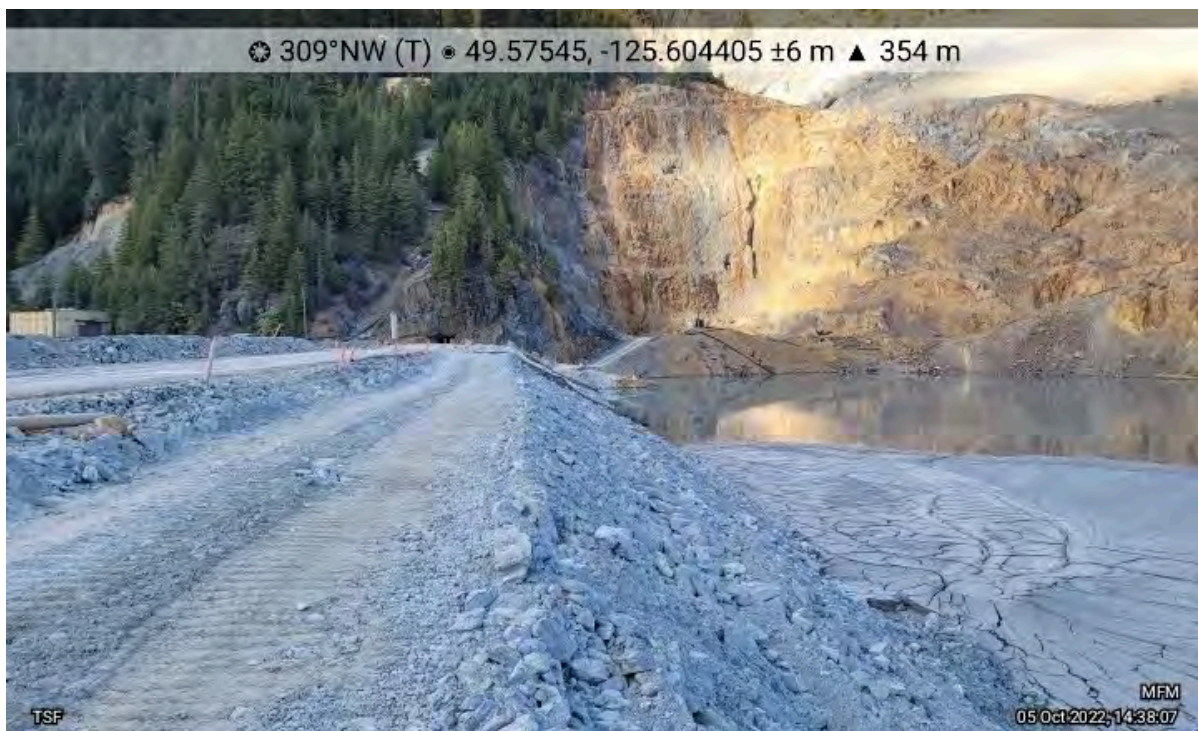
Photo 2: Lynx TDF looking northwest. Crest elevation is at 373.5 m.

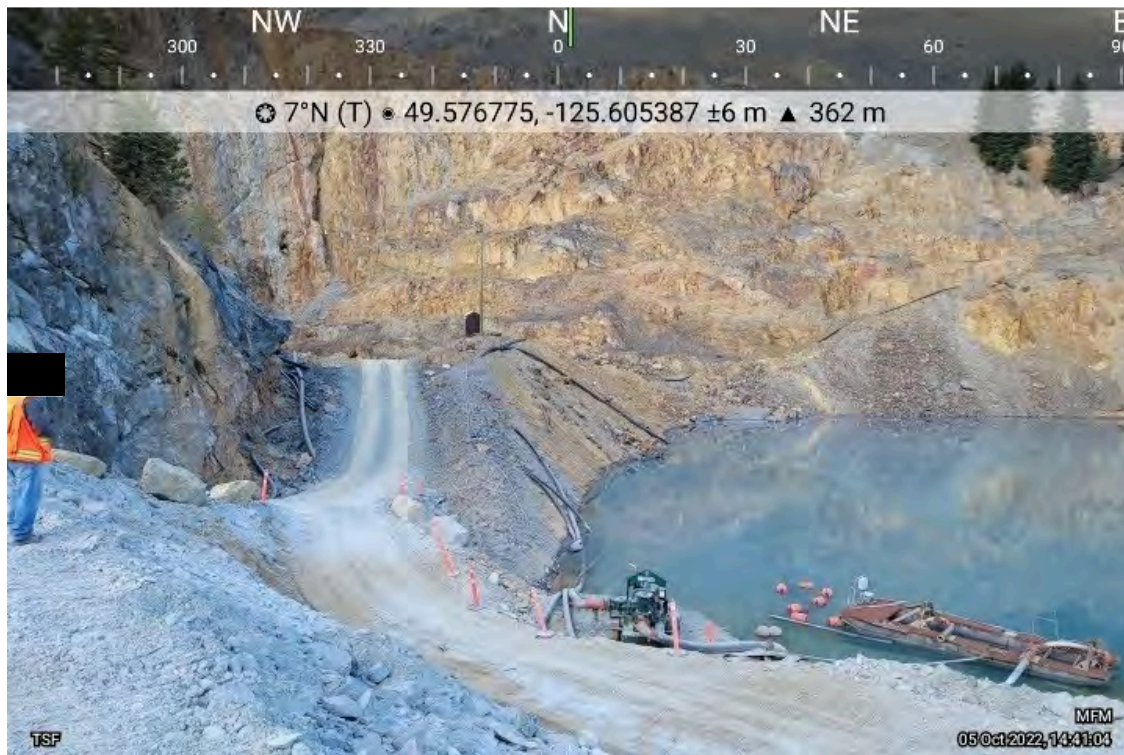
Photo 3: Tailings pond at the north end (back) of the Lynx TDF.

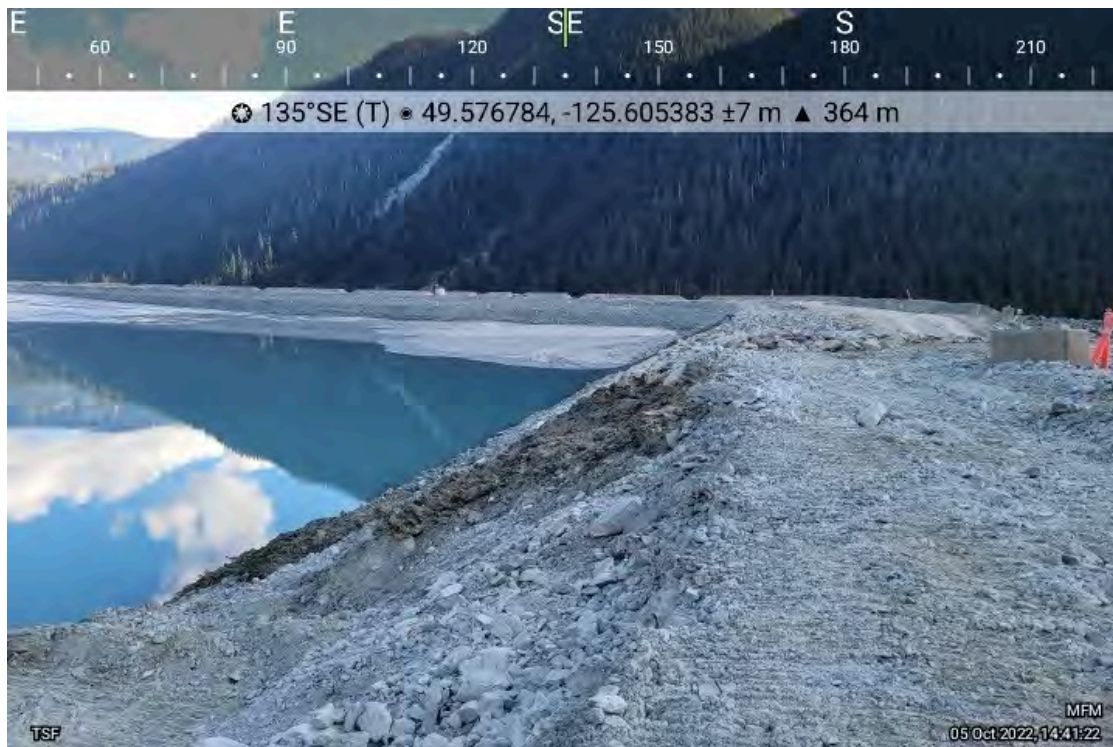
Photo 4: Lynx TDF looking southeast with the boundary of the tailings pond at the west end of the TDF covering about 2/3 of the tailings surface.

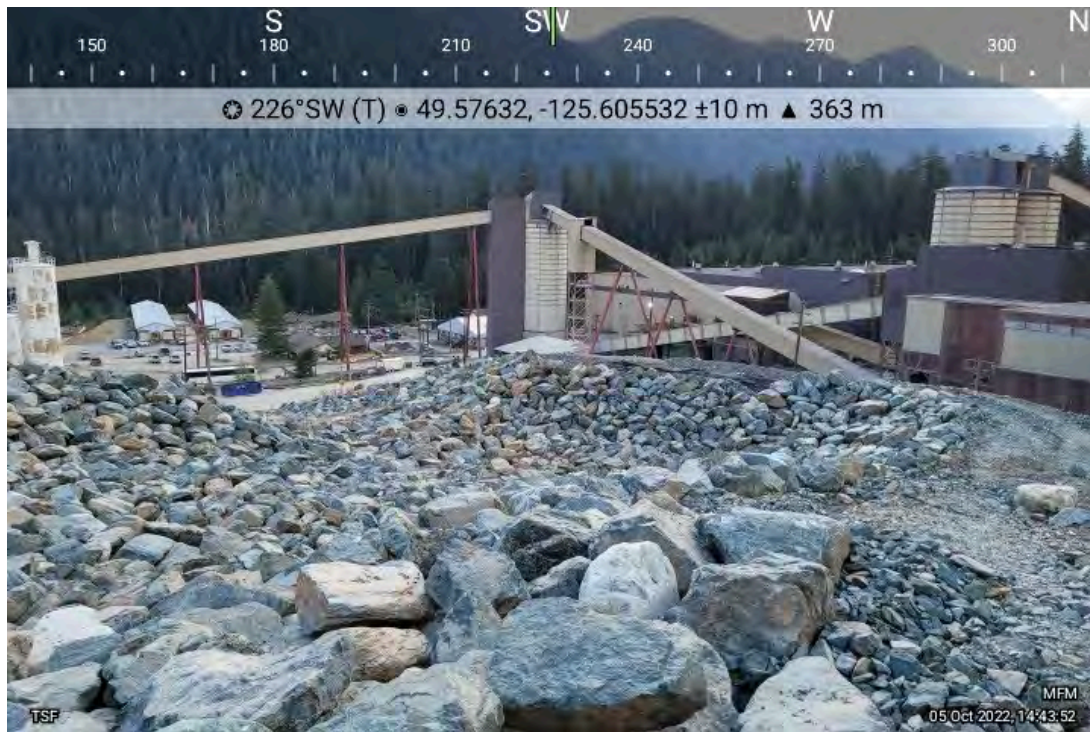
Photo 5: Lynx TDF spillway looking downstream to the mill and camp sites. Riprap was stable with no evidence of deterioration or segregation of sizes. Riprap stones are angular to subangular.

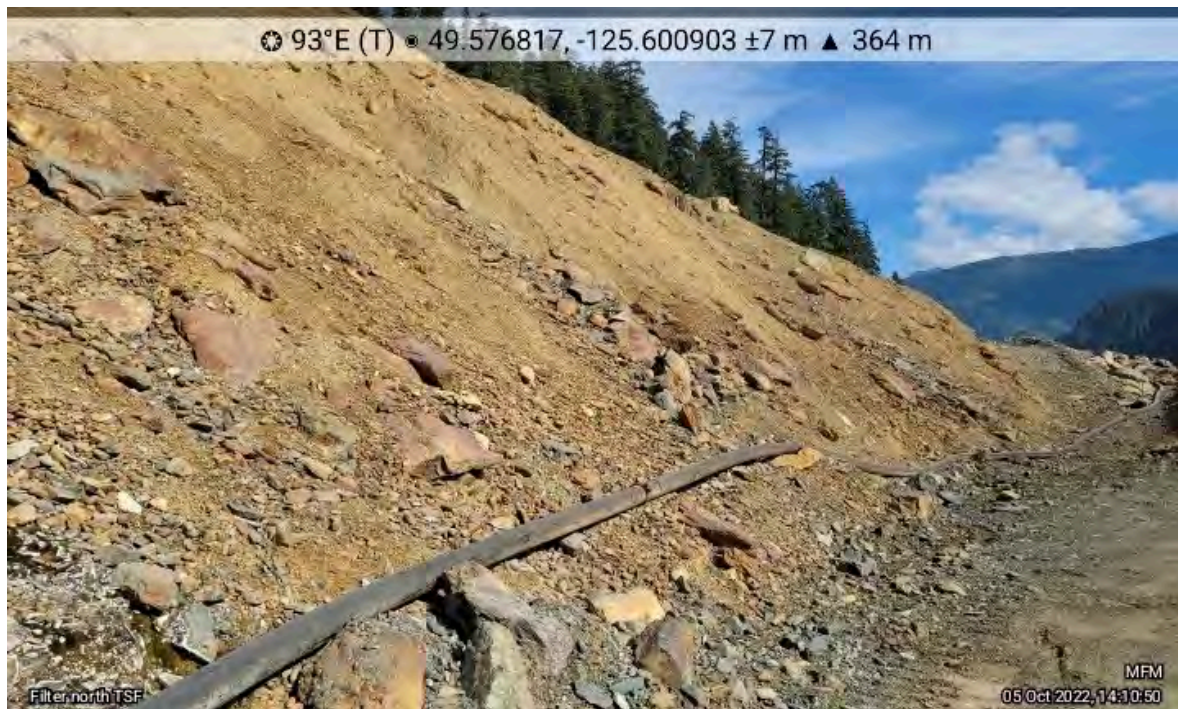
Photo 7: Lynx TDF East Abutment at WRD1, looking southeast.

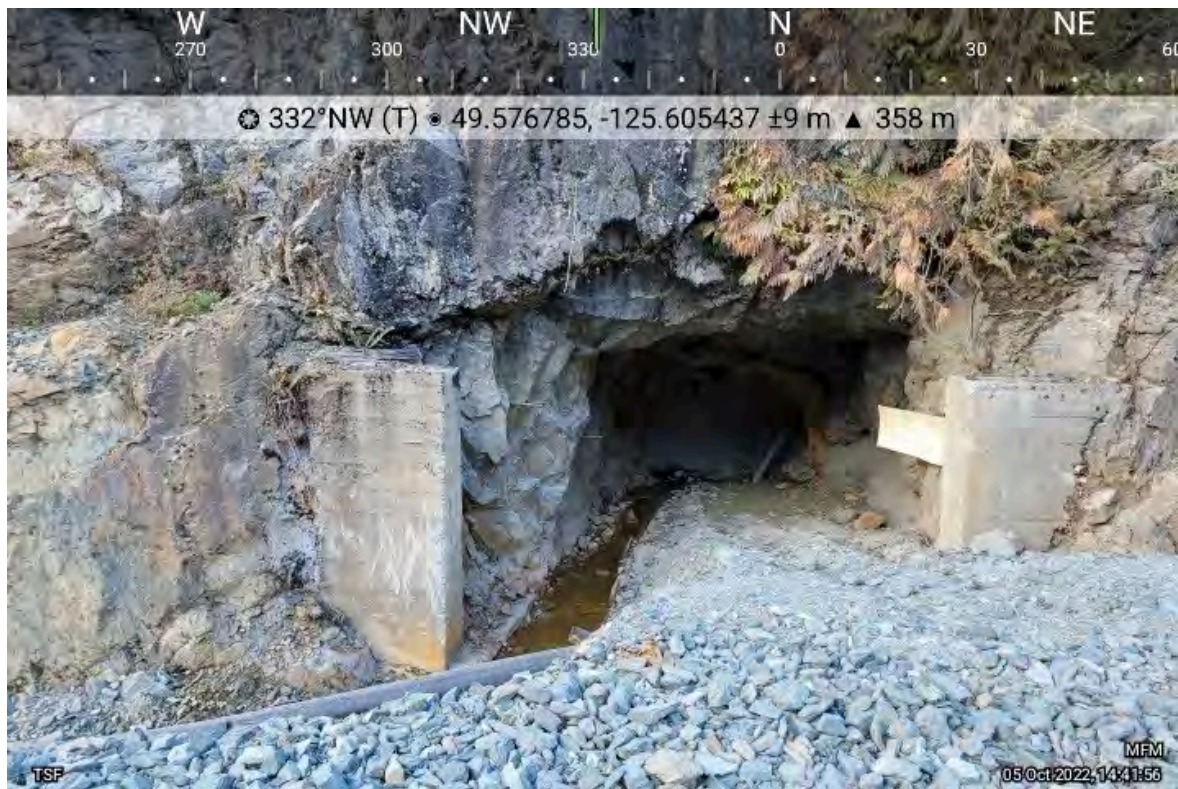
Photo 8: Lynx TDF West Abutment showing 10 Level East Portal, looking north. Ongoing drainage flows from the portal. The portal is to be plugged and sealed before next dam raise construction.

The 10 Level East Portal in the Lynx TDF West Abutment shows ongoing drainage flows from the portal. This portal needs to be plugged and sealed before next dam raise construction to El. 376.5 m. See Photo 8.

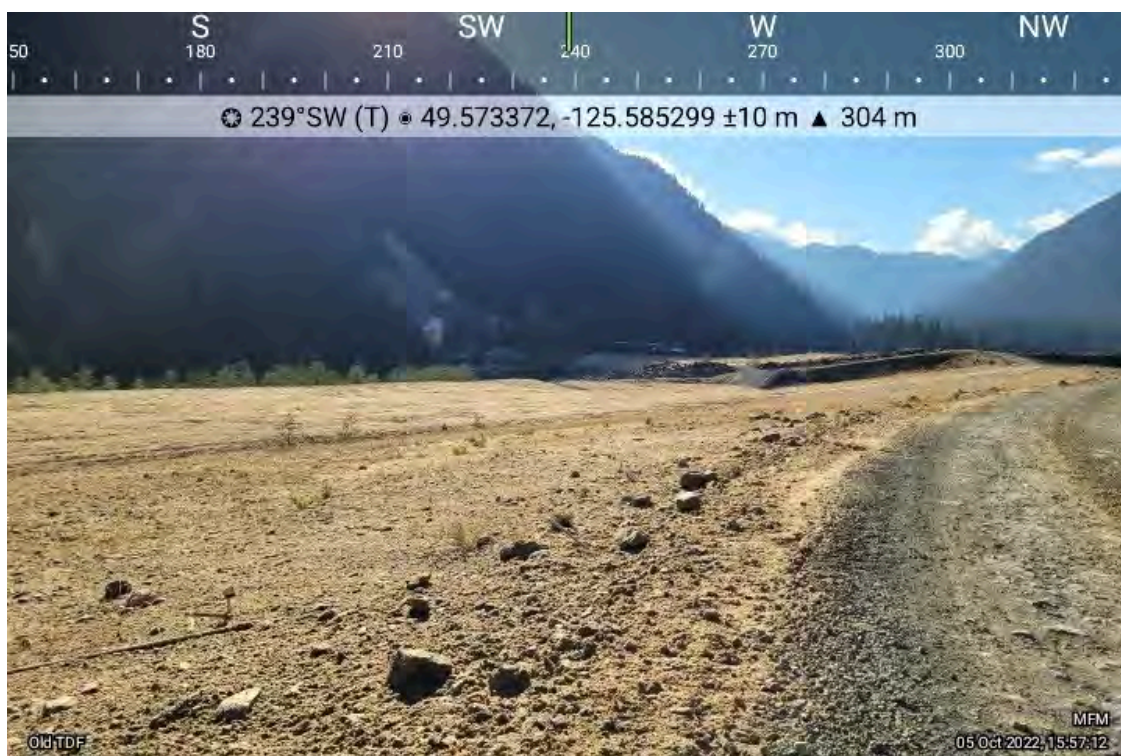
Photo 10: Hydroseeding was recently implemented along the berms of the Old TDF. This photo is looking towards the southwest.

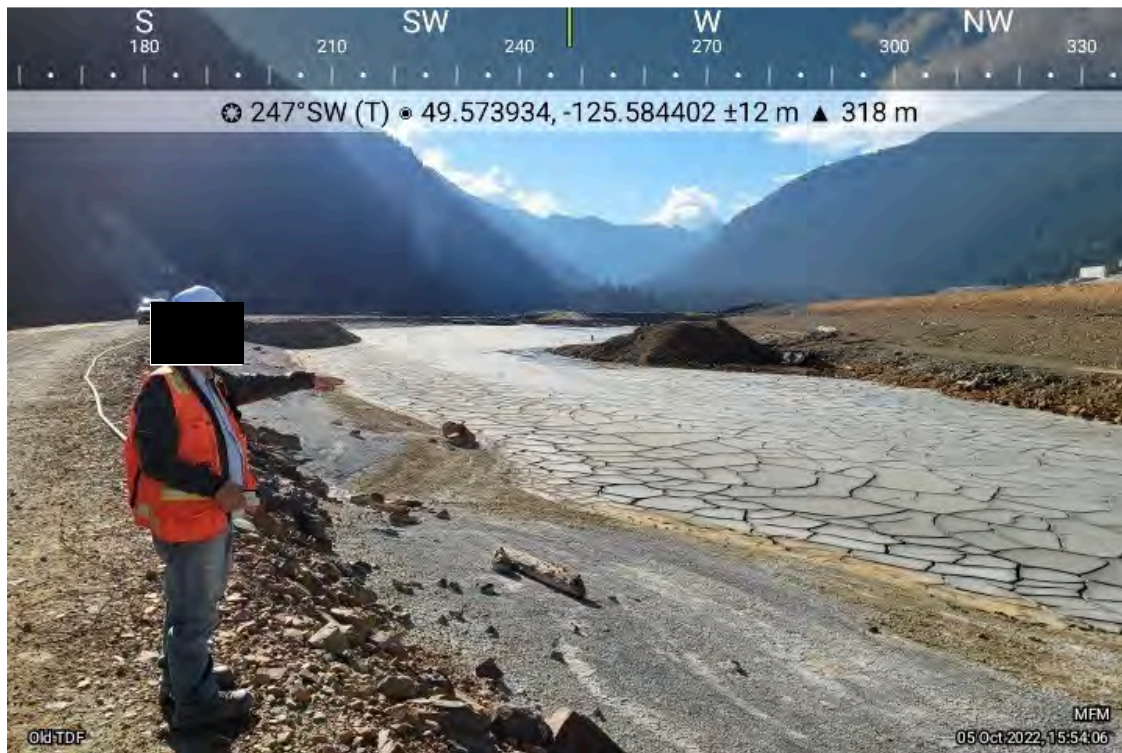
- Rusted amalgamated paste area (APA) decant grates:
  - a. West decant: the bottom 2-3 cm of the vertical grating bars has been dissolved leaving a 2-3 cm gap at the bottom of the decant inlet.
  - b. East decant: the grate has degraded in a similar manner with approximately half of the bottom 2 cm's of the vertical grating bars being dissolved.
- Periodic cleaning and grading are recommended in the vicinity of the orifices of the East and West Decant Pipe Drop structures.
- The East Strip continues to be obstructed by tailings. The tailings should be removed to allow unobstructed flow from the east abutment to the spillway culverts. This was discussed with MFM at the time of the site visit. See Photographs 11, 12 and 13.
- The West Strip of the Old TDF was filled with tailings obstructing the flow capacity of the spillway culvert pipes. See Photographs 11, 12 and 13.

Photo 11: East Strip of the Old TDF continues to be filled with tailings. This conduit needs removal of tailings before the wintertime.

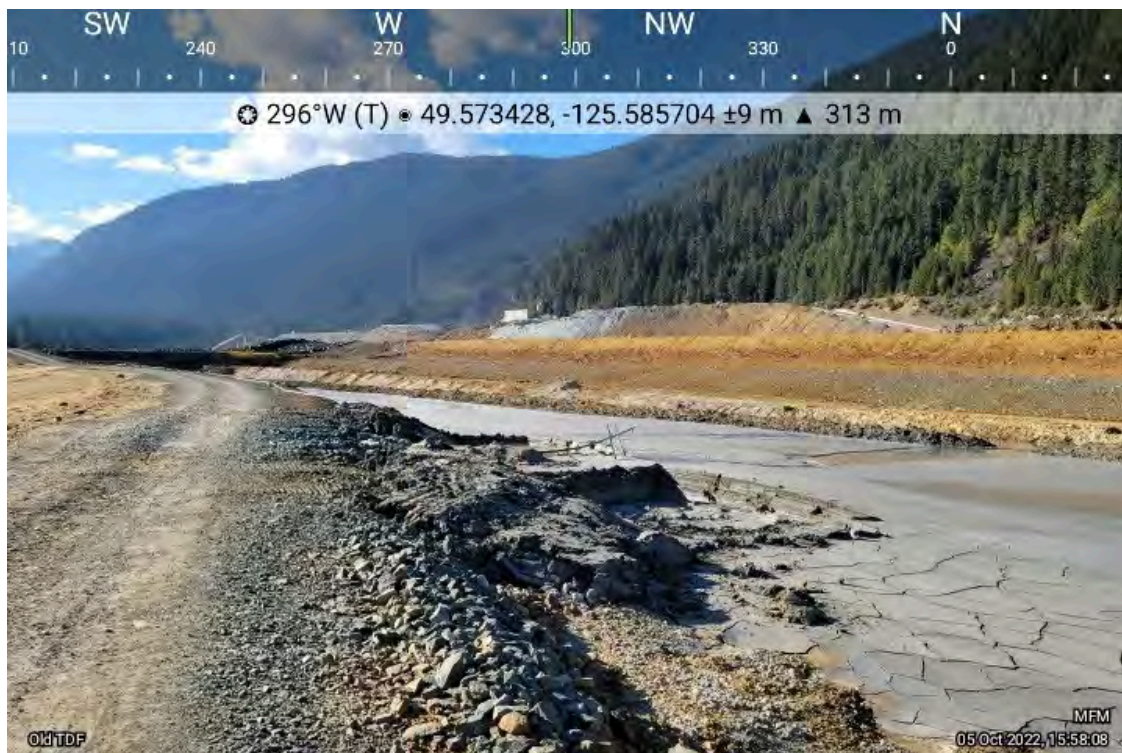
Photo 12: East Strip of the Old TDF continues to be filled with tailings. This conduit needs removal of tailings before the wintertime.

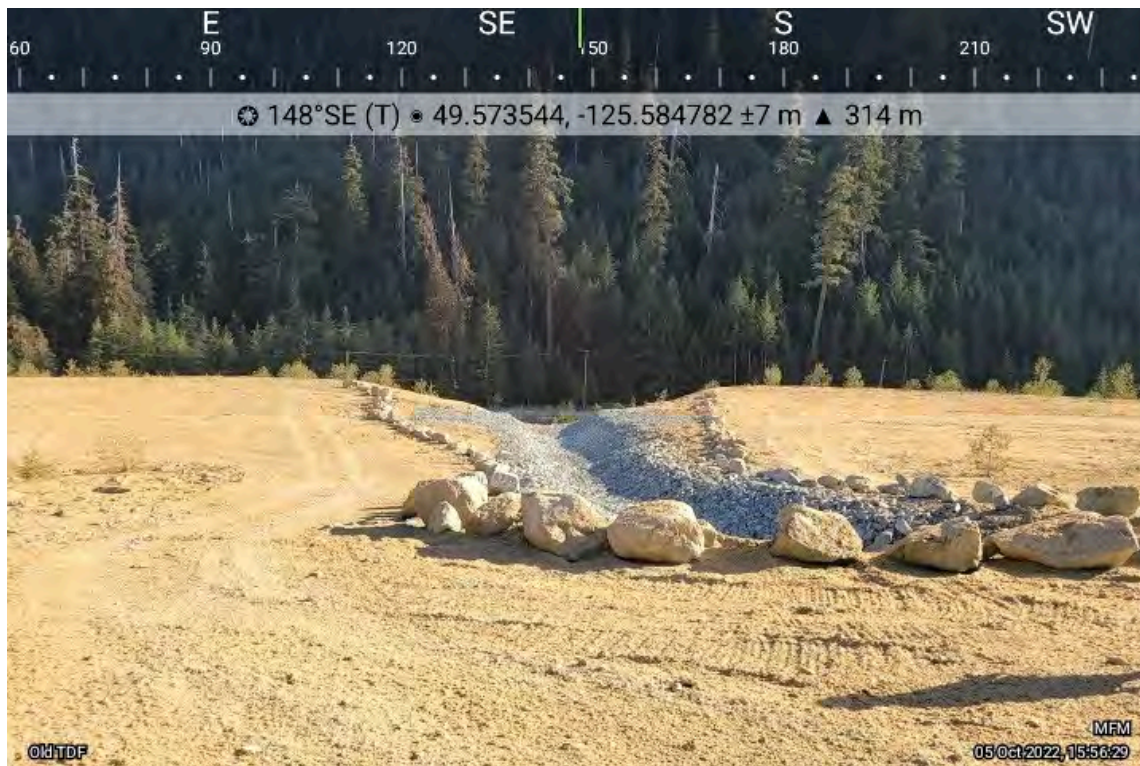
Photo 14: Old TDF Channel 1 looking downstream. The riprap is stable and in good condition.

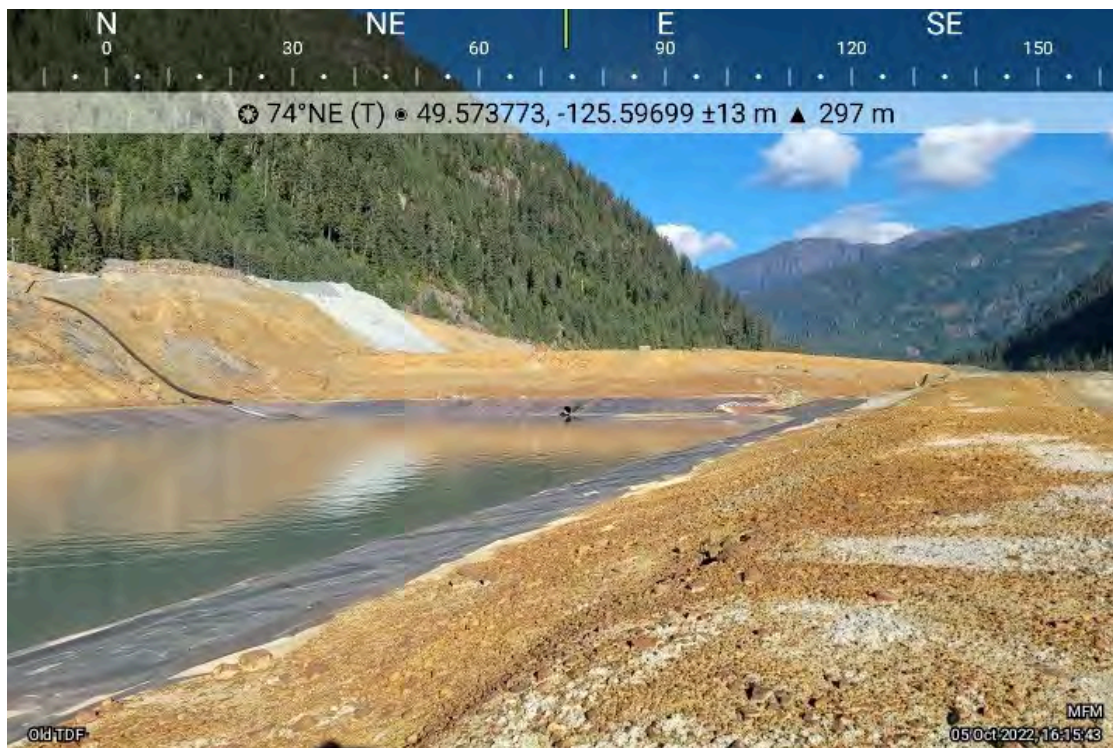
Photo 15: Surge Pond looking northeast. No unusual performance was observed.

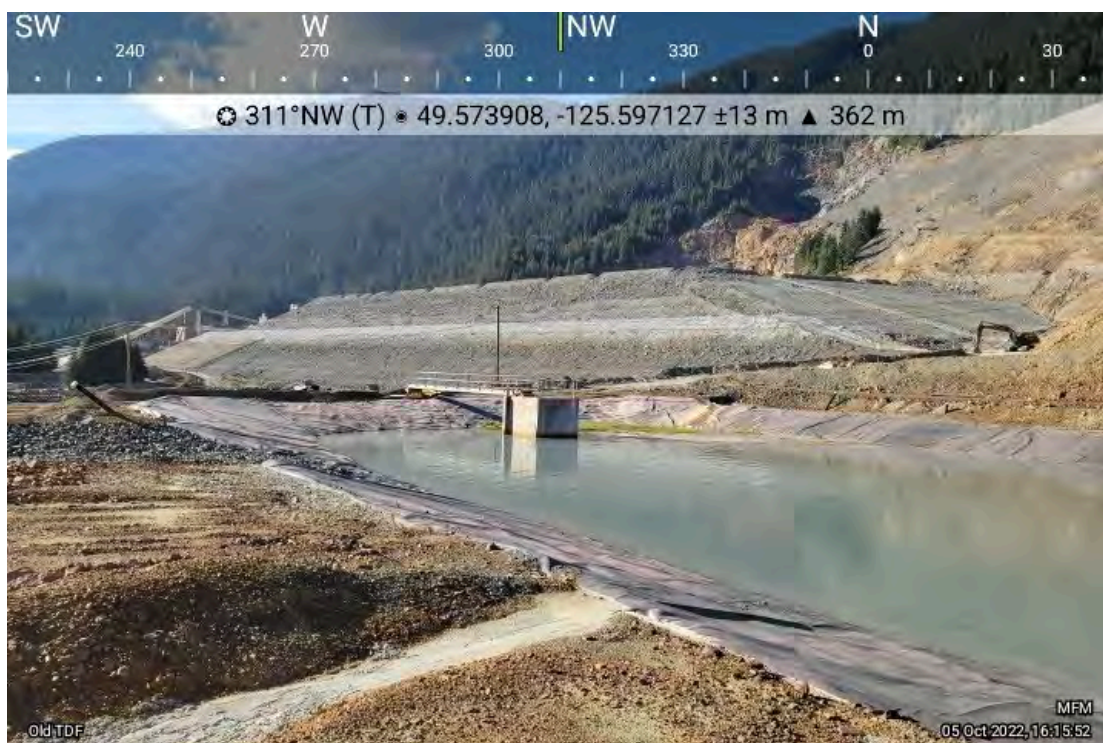
Photo 16: Surge Pond looking northwest. No unusual performance was observed.

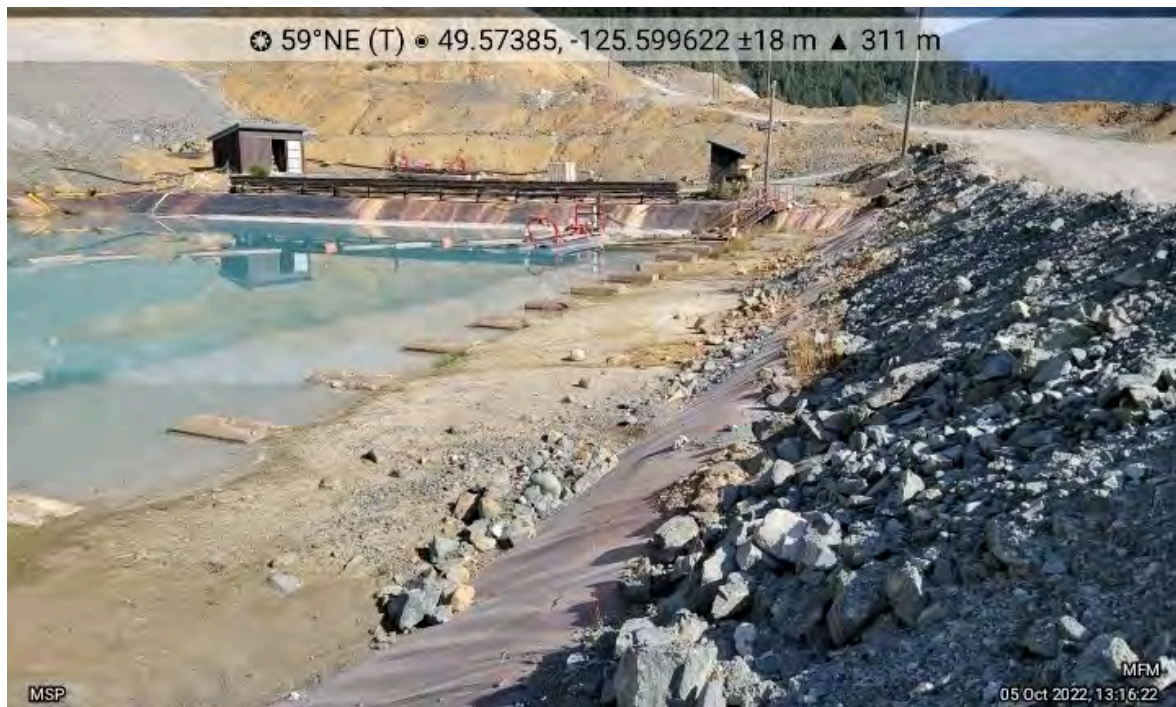
Photo 17: Super Pond looking northeast. No unusual performance was observed.

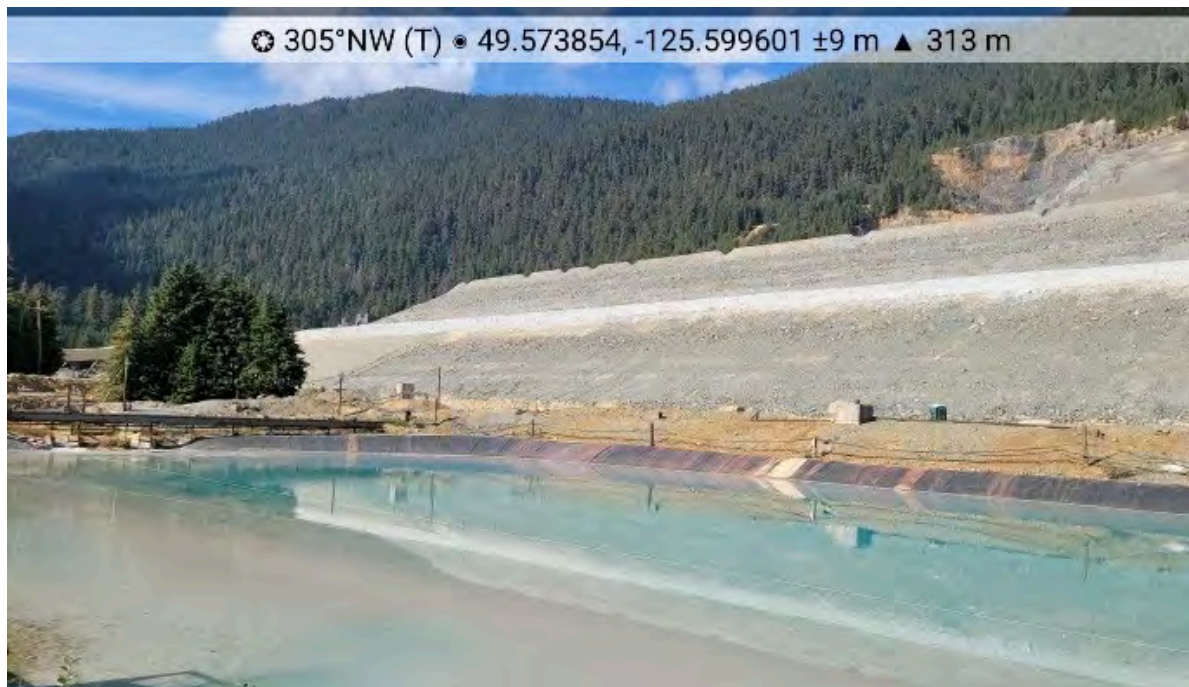
Photo 18: Super Pond looking northwest. No unusual performance was observed.

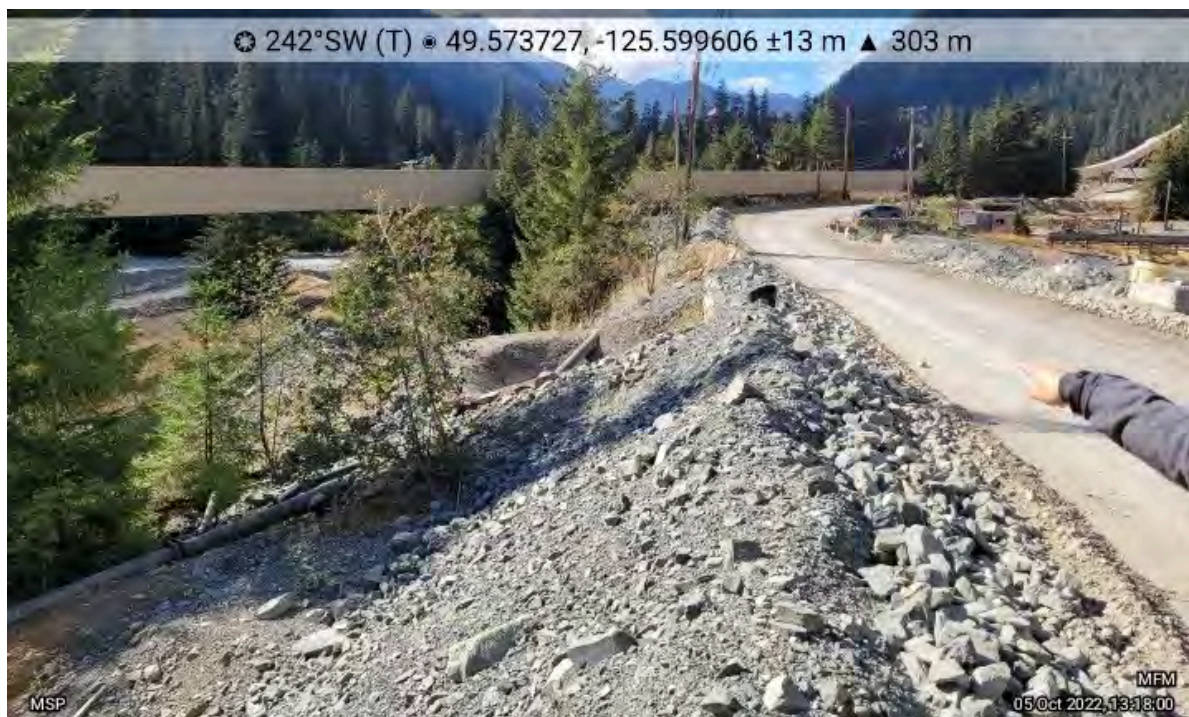
Photo 19: Super Pond looking at the downstream slope and the crest of the south retention berm of Super Pond. No unusual performance was observed.

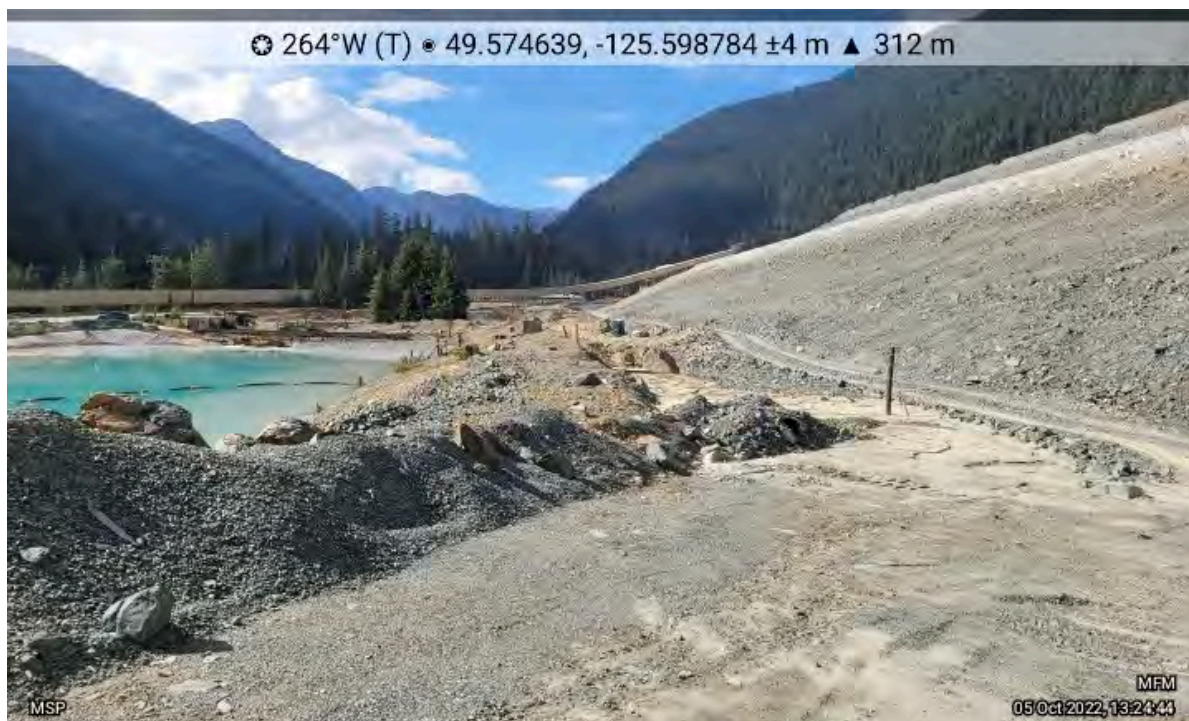
Photo 20: Super Pond looking upstream to the top of the pond and the berm that separates Super Pond from the downstream toe of Lynx TDF. No unusual performance was observed.

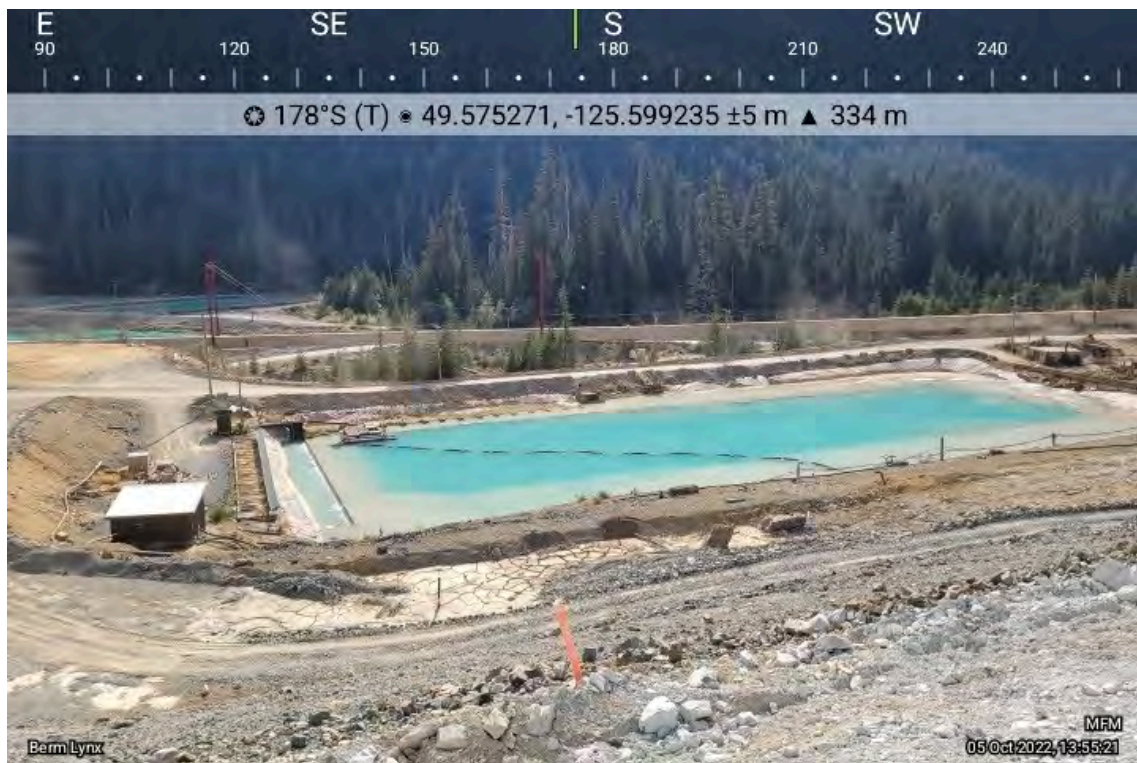
Photo 21: Super Pond looking downstream from the downstream bench (El. 343 m) of Lynx TDF

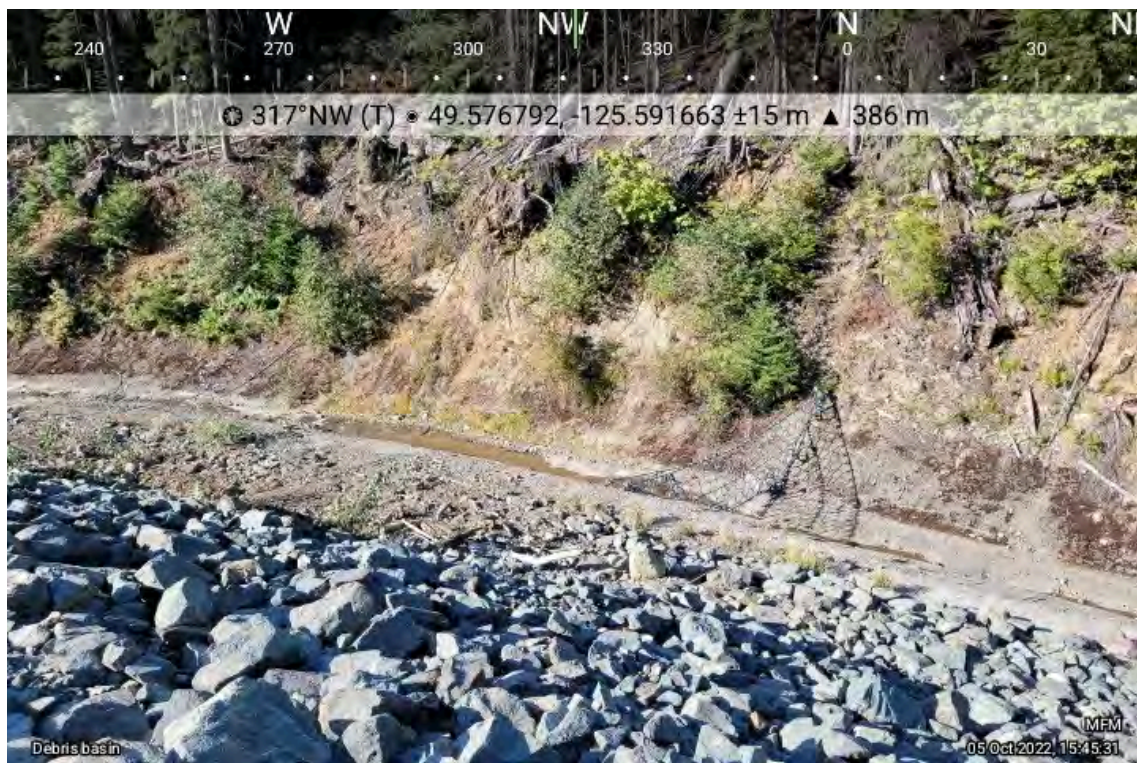
Photo 22: West end of the Lower Lynx Diversion Ditch at the location of the interim debris retaining net

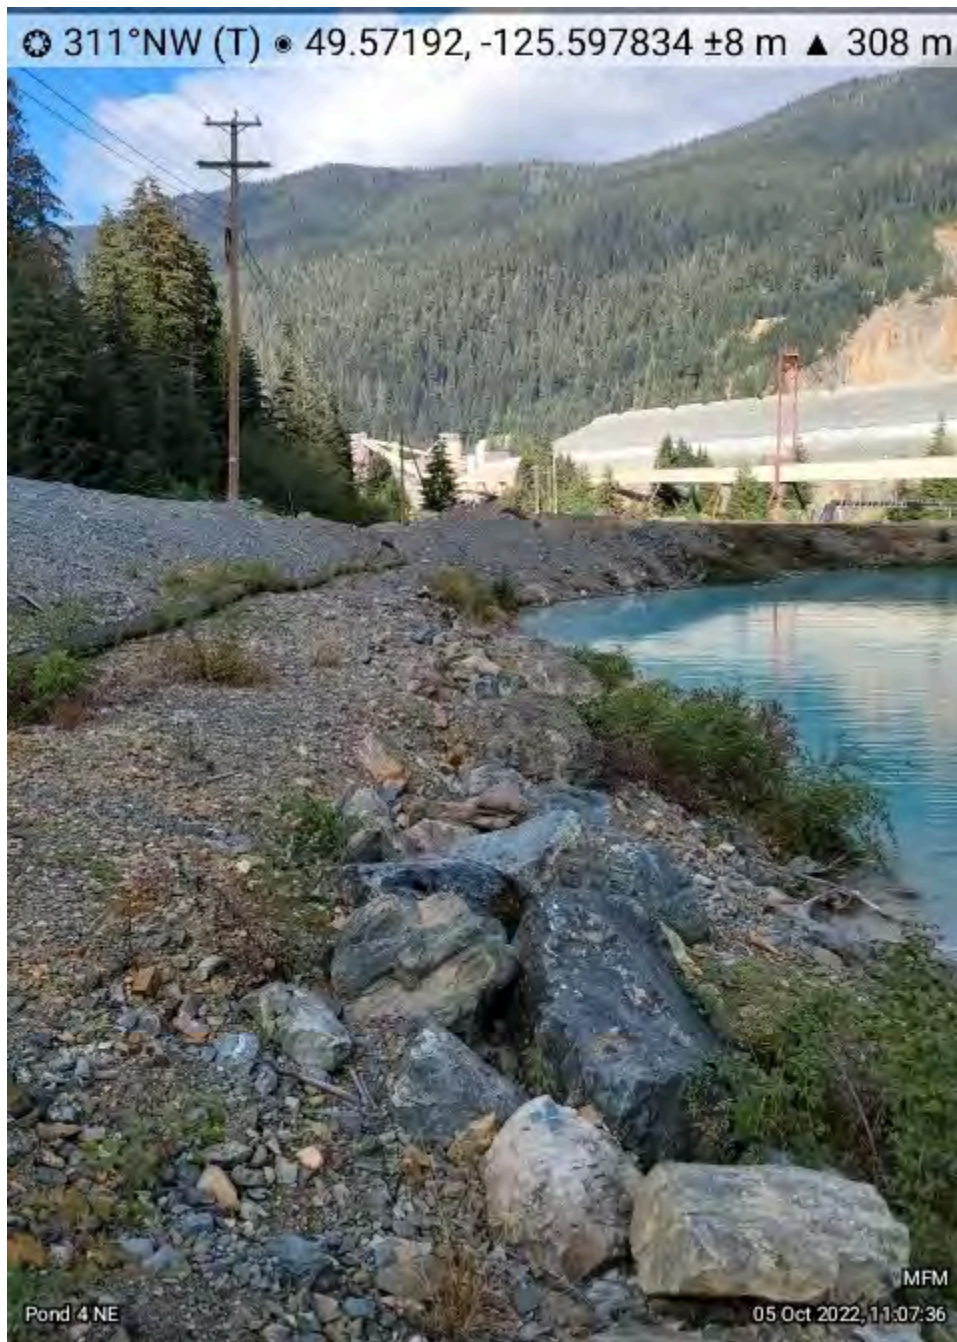
Photo 24: Polishing Pond 4. No unusual performance was observed.

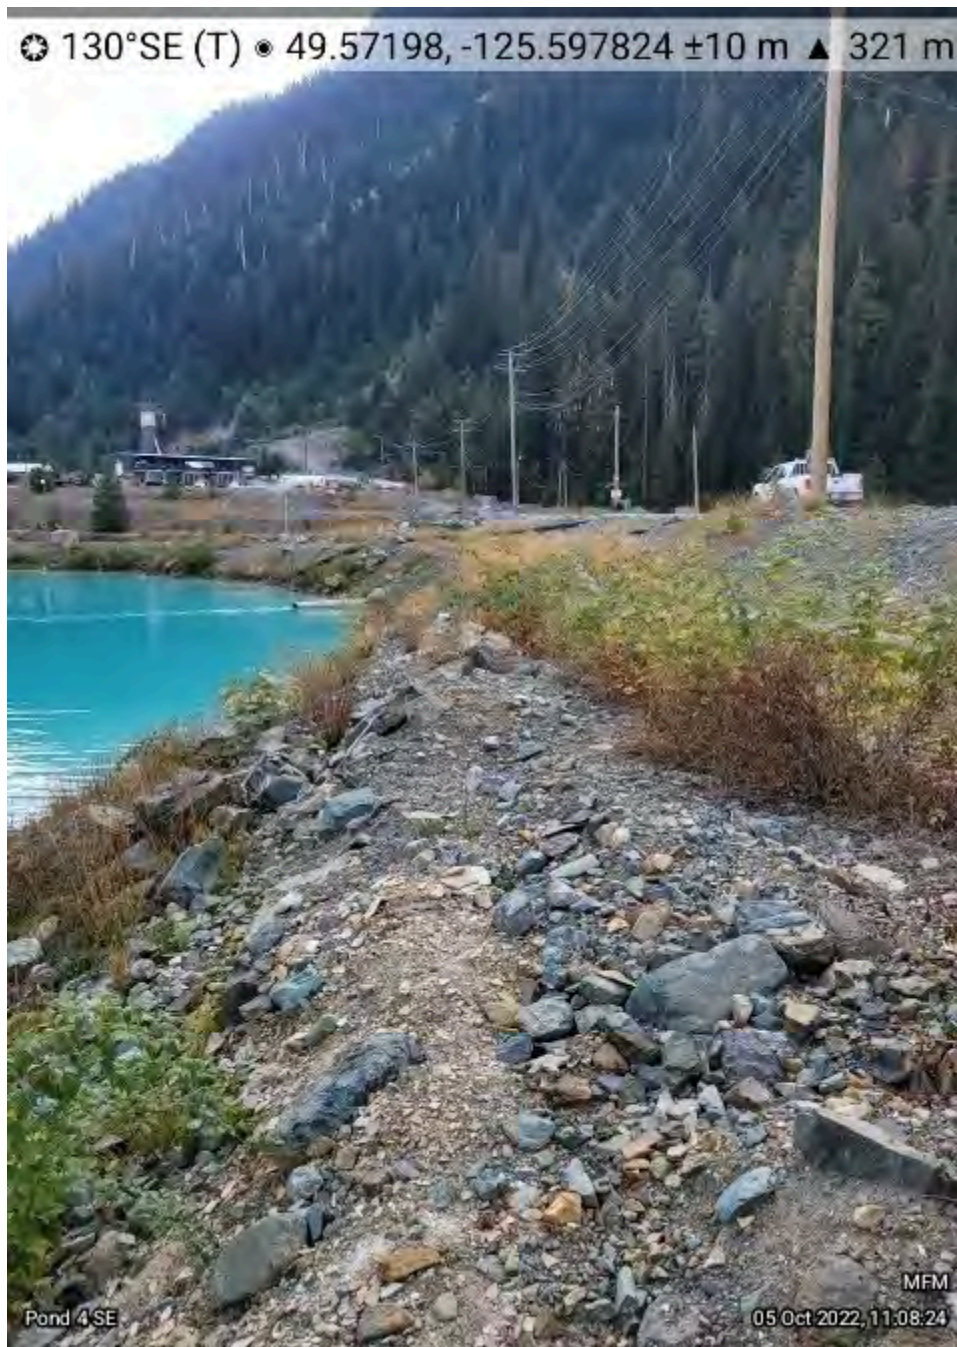
Photo 25: Polishing Pond 4. No unusual performance was observed.

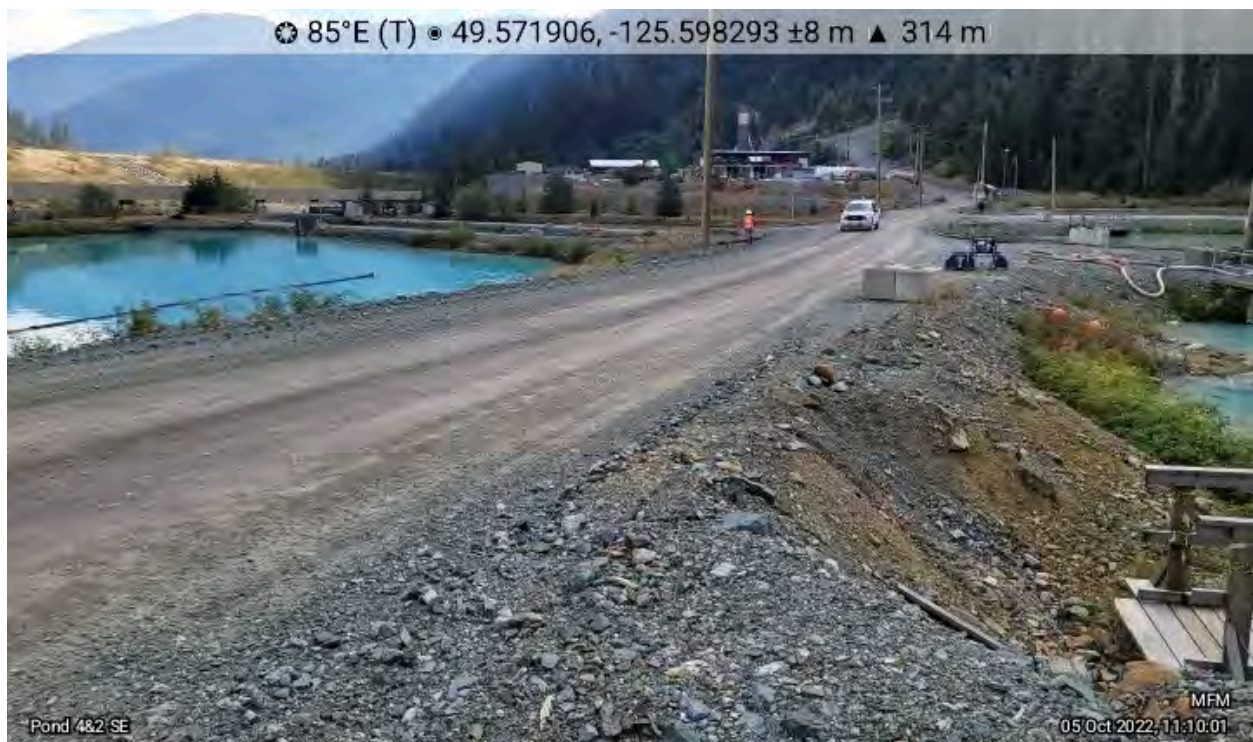
Photo 26: Crossing between Polishing Pond 4 and Polishing Pond 2. No unusual performance was observed.

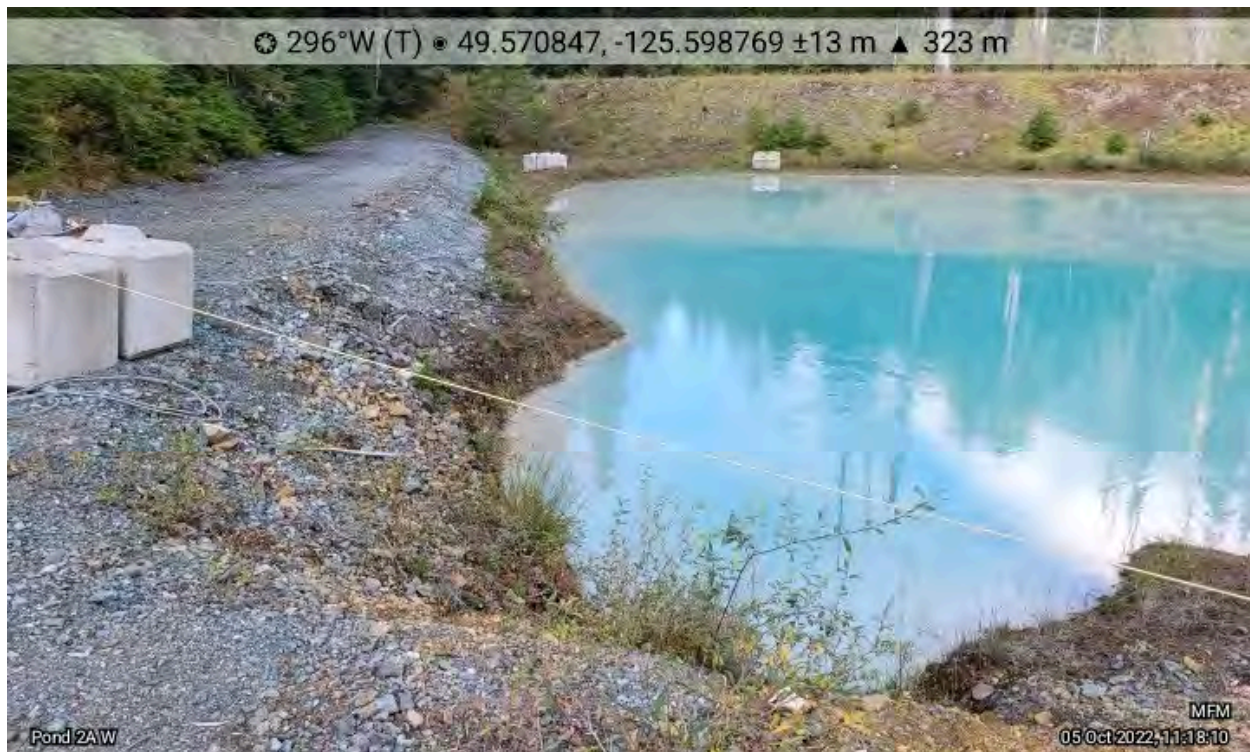
Photo 28: Polishing Pond 2A looking West. No unusual performance was observed.

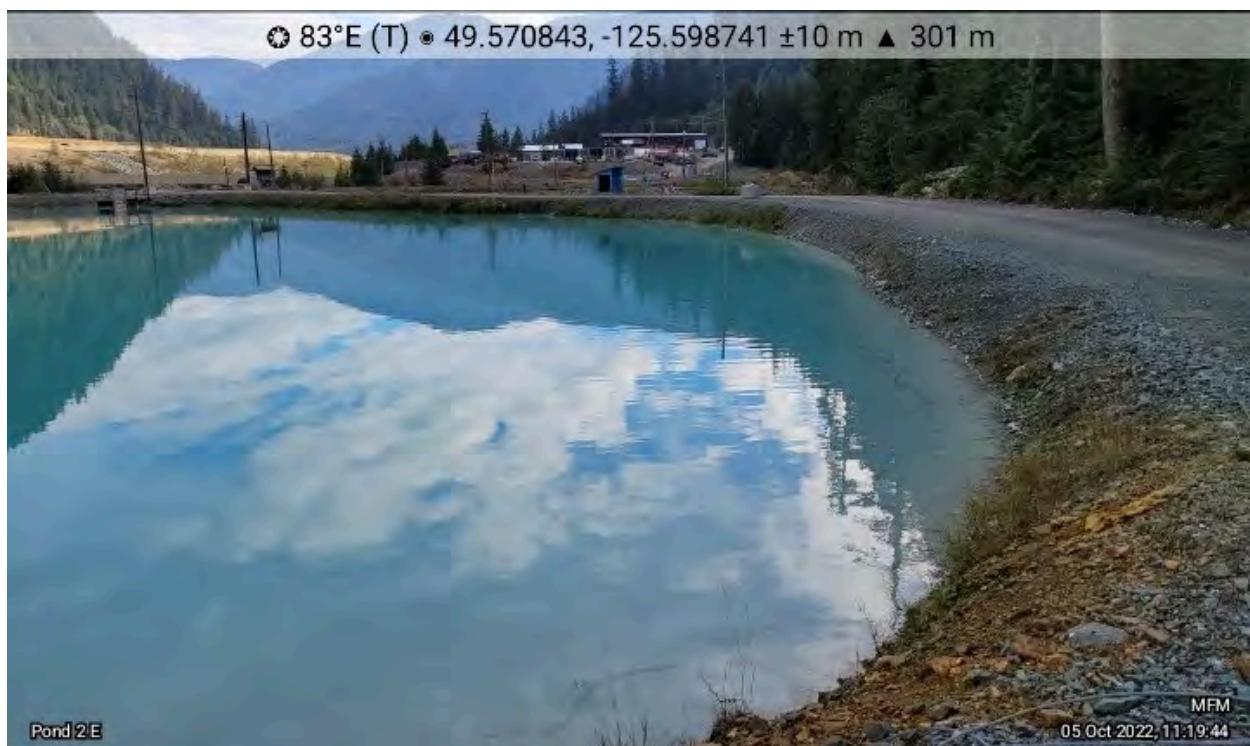
Photo 29: Polishing Pond 2 looking East. No unusual performance was observed.

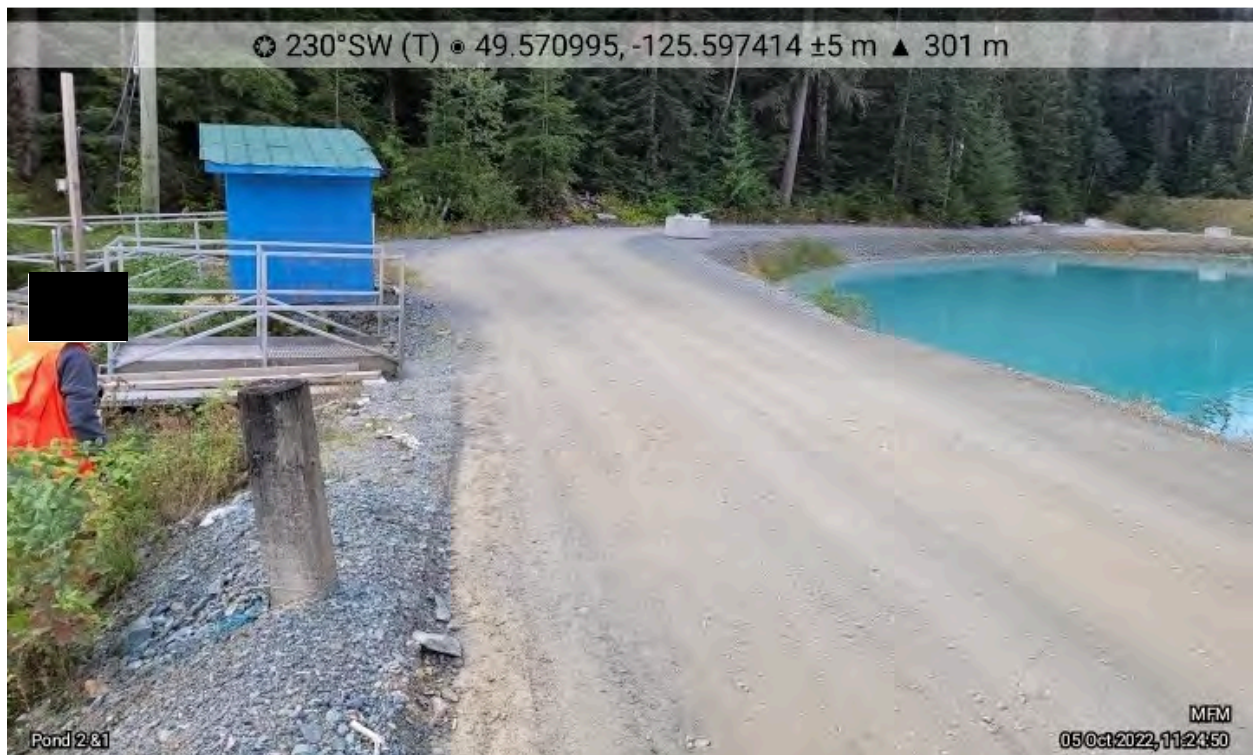
Photo 31: Middle berm between Polishing Pond 2 and 1 looking Southwest. No unusual performance was observed.
