# 2022 OLD TDF DAM SAFETY INSPECTION REPORT

MYRA FALLS MINE LTD.  
A TRAFIGURA COMPANY  
CAMPBELL RIVER, BC

PROJECT NO.: NX14001B4.3  
DATE: 29 MARCH 2023

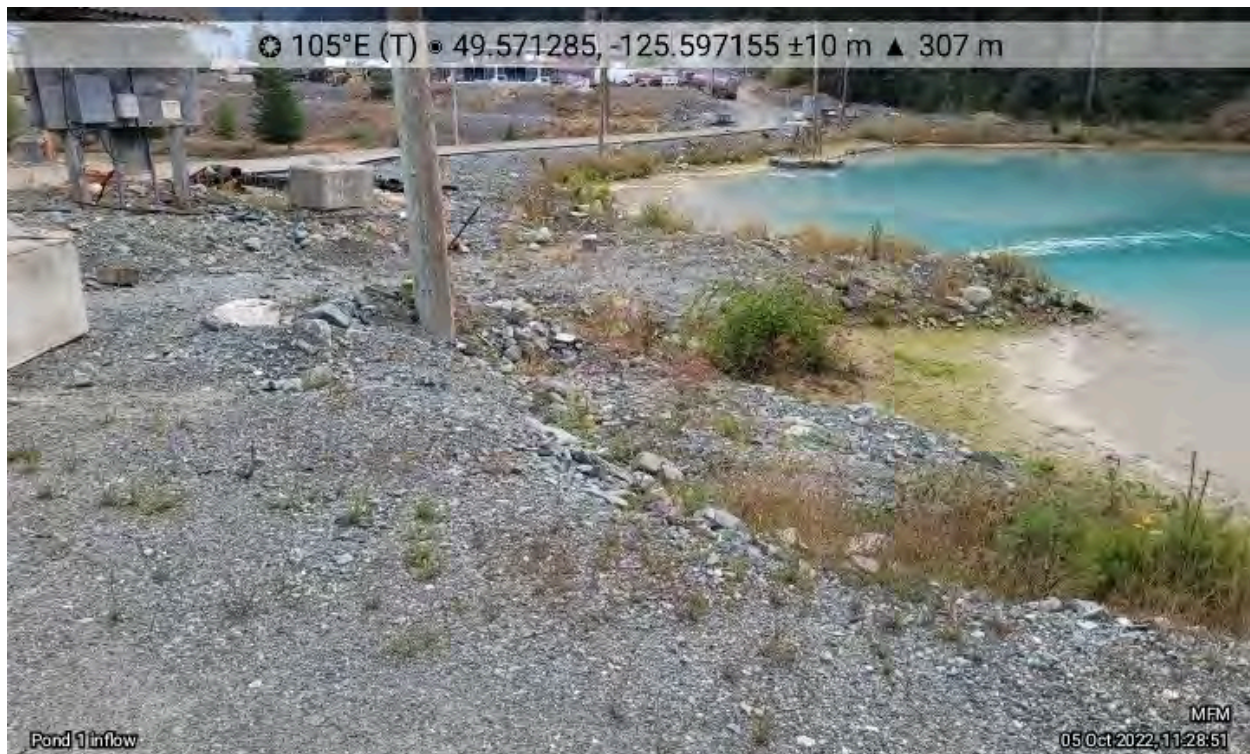
Photo 32: Polishing Pond 1 inflow looking East. No unusual performance was observed.

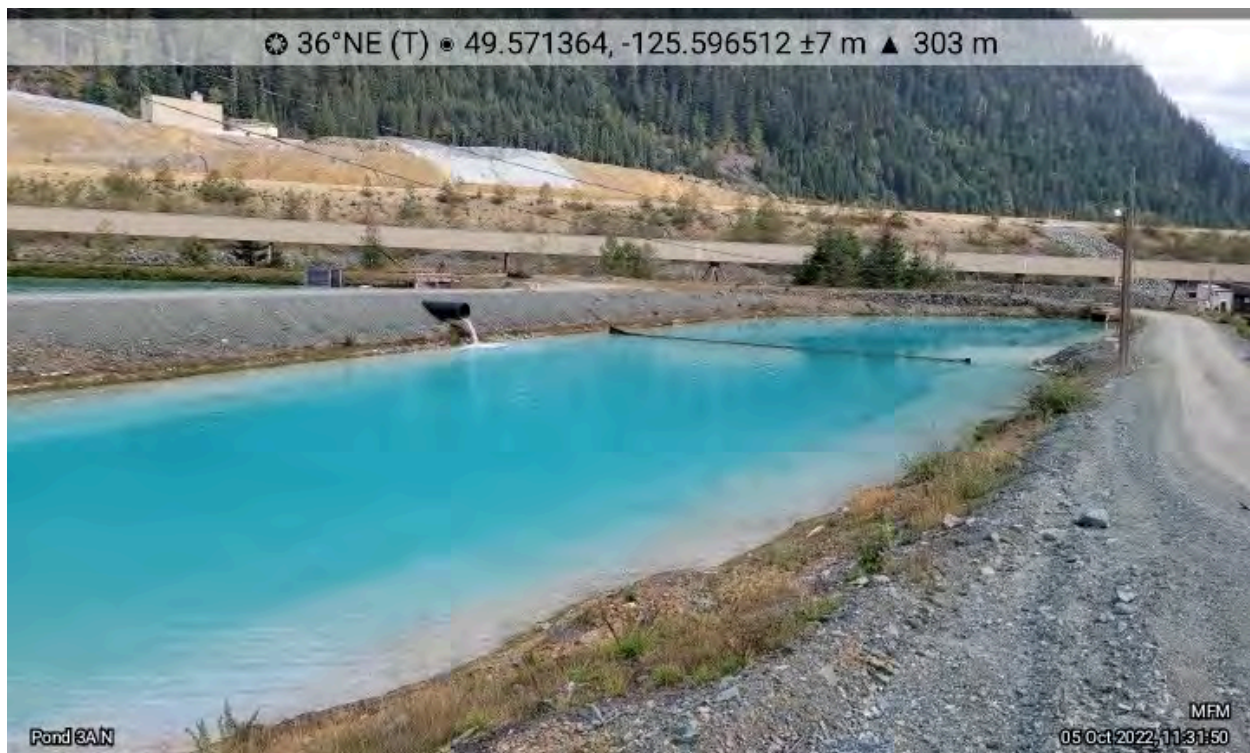
Photo 33: Polishing Pond 3A looking North. No unusual performance was observed.

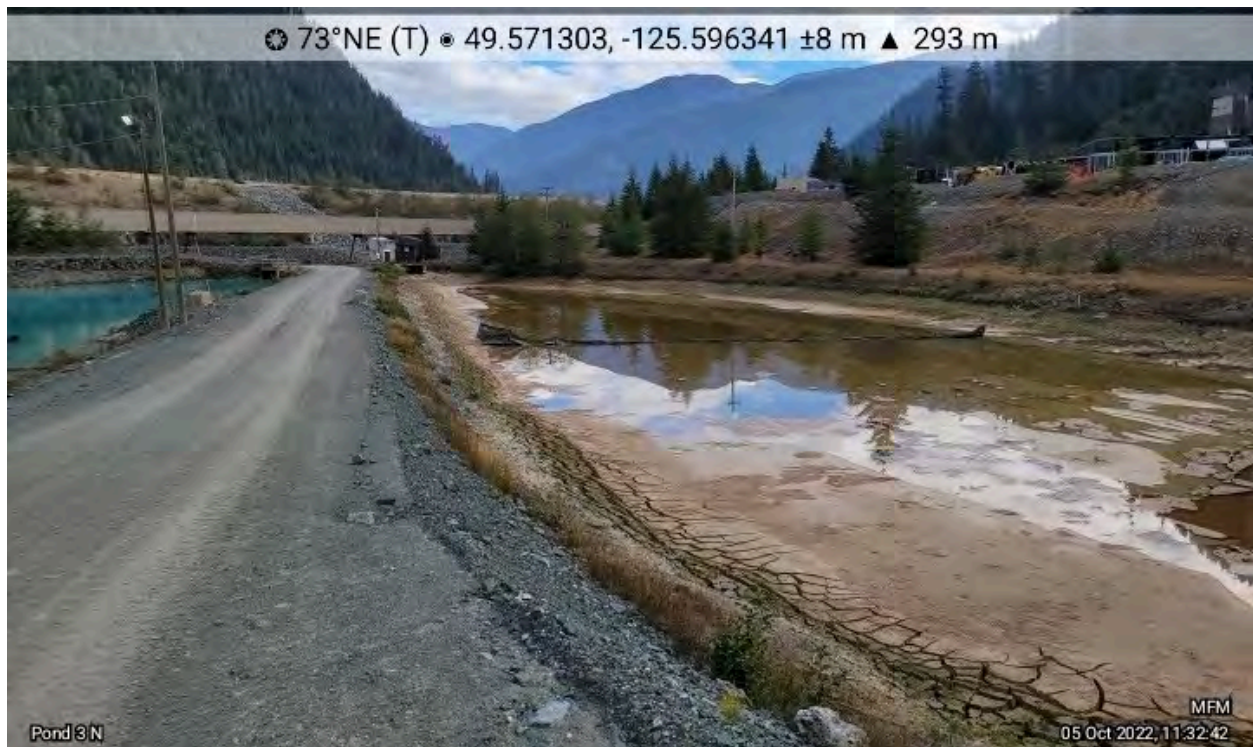
Photo 34: Polishing Pond 3 looking North. Observed to be empty

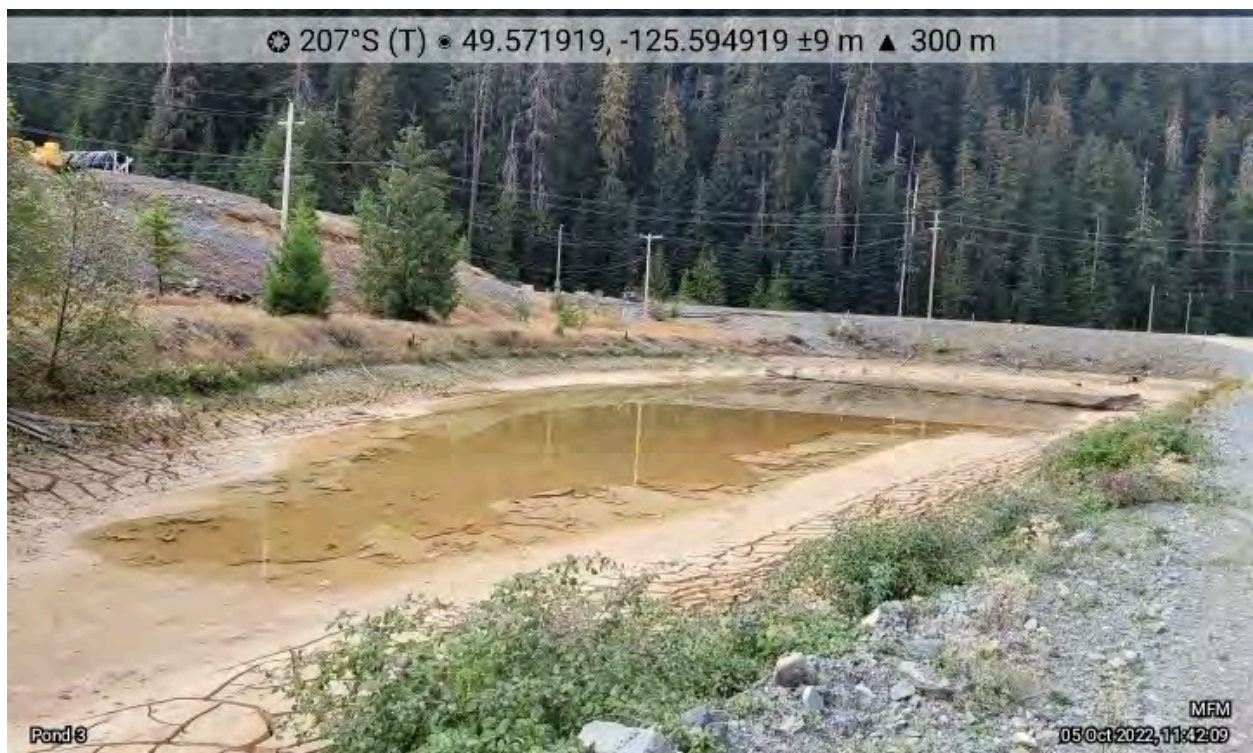
Photo 35: Polishing Pond 3 looking South. Observed to be empty.

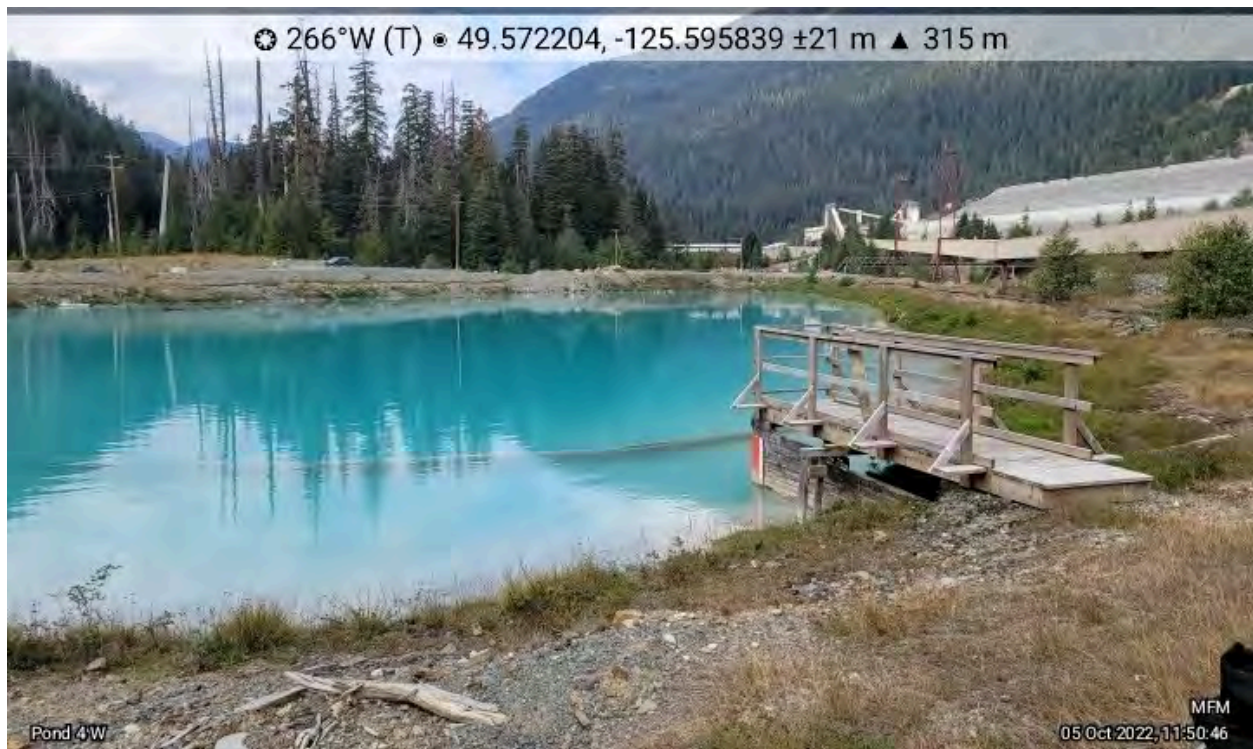
Photo 36: Polishing Pond 4 looking West. No unusual performance was observed.

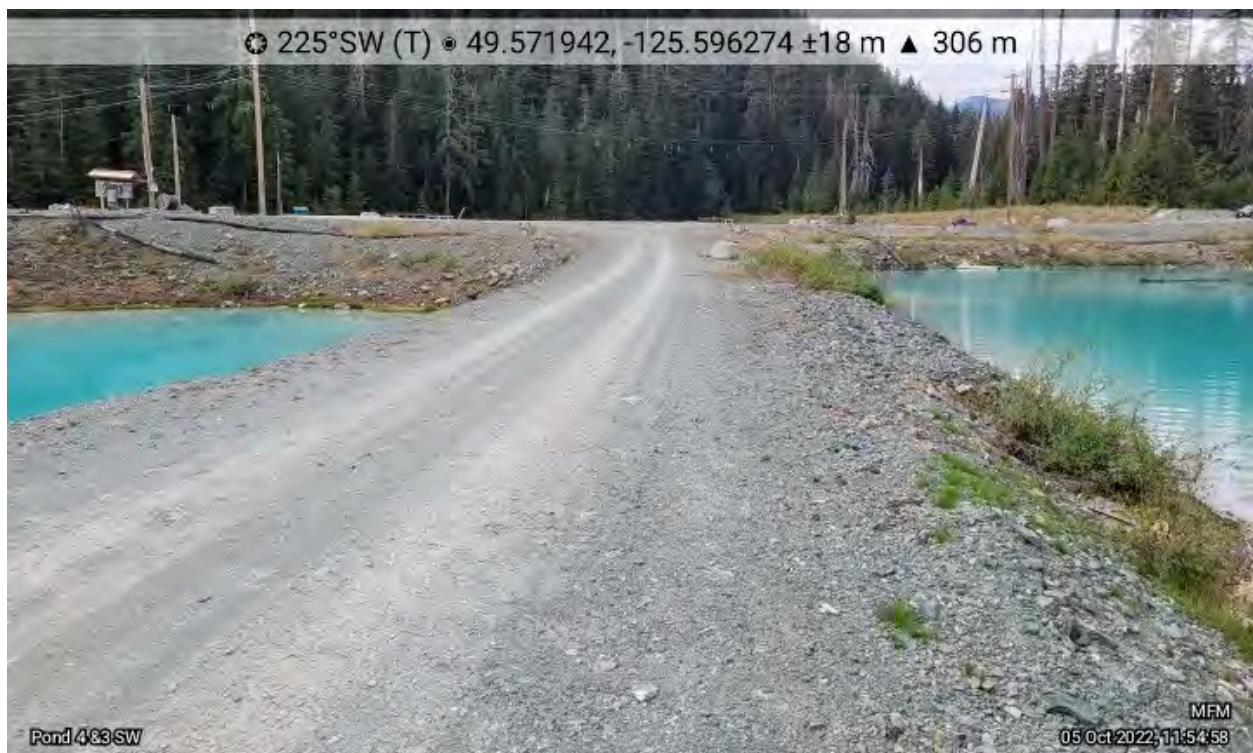
Photo 37: Middle berm between Polishing Ponds 4 and 3 looking Southwest. No unusual performance was observed.
